25 March 2019

Ref: L10776g

Geotechnical investigation, new reticulation pipeline alignment, Molong NSW

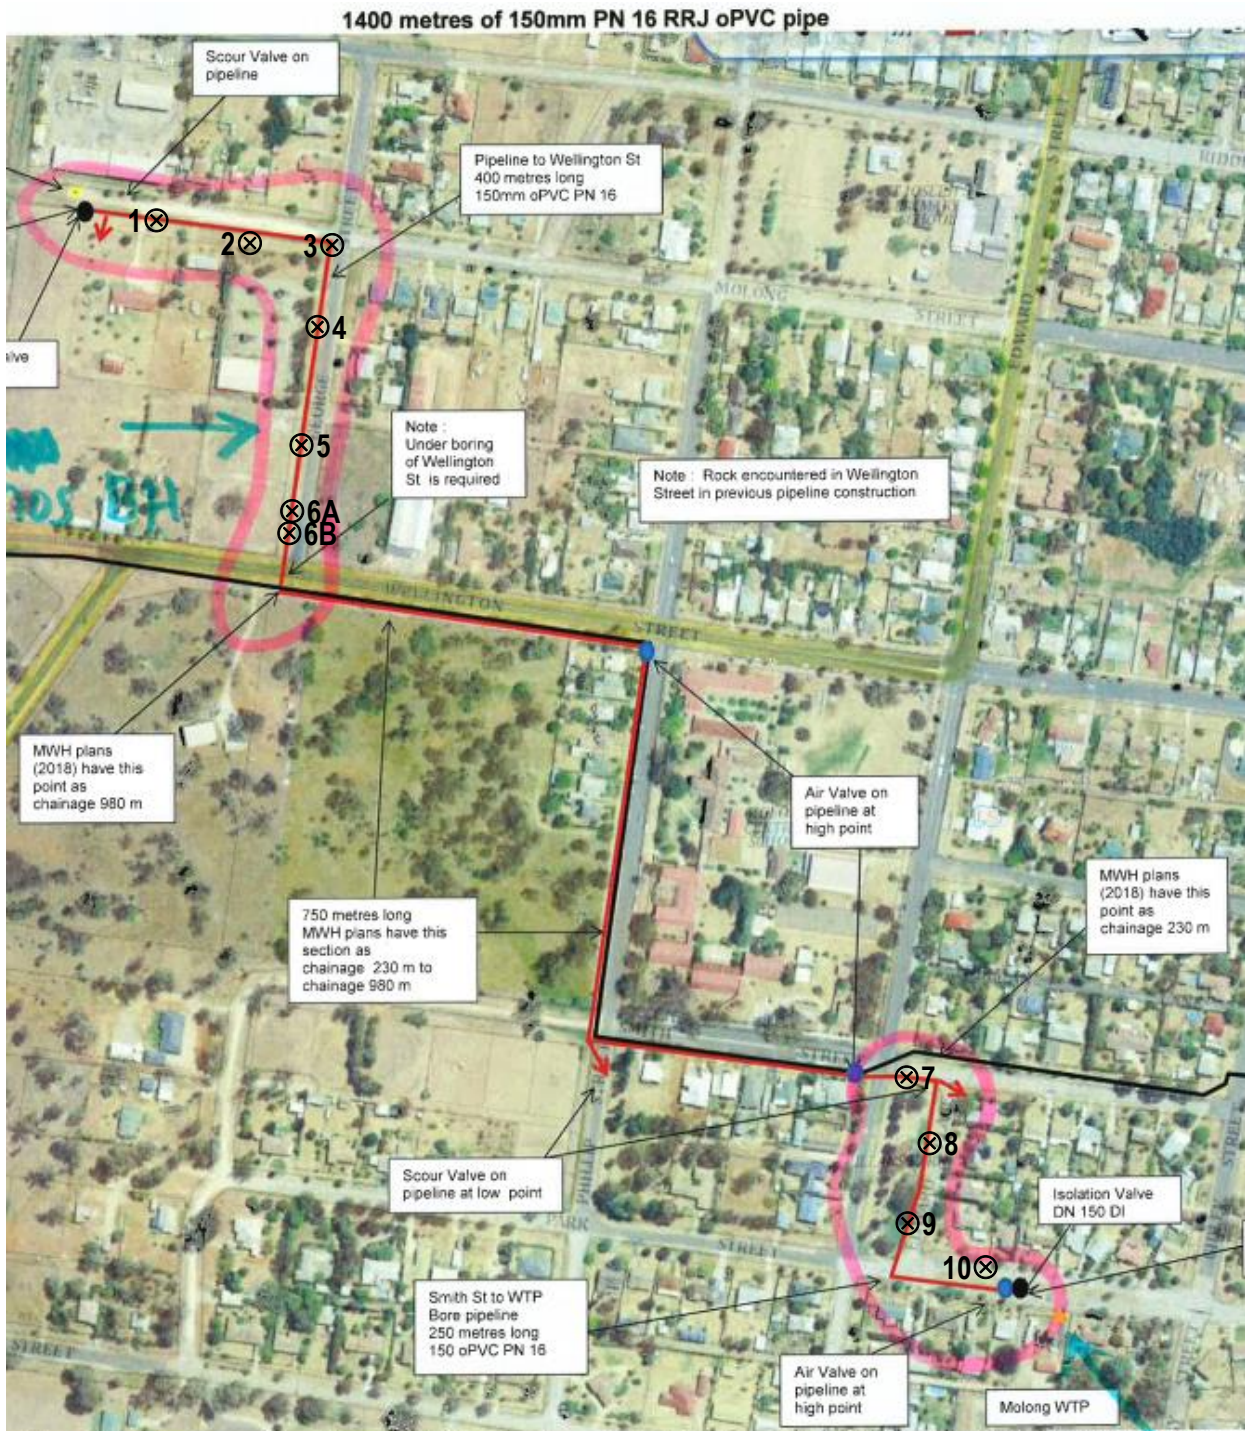
Figure 1. Site plan and borehole location		
Proposed reticulation pipeline, Molong NSW		
	Envirowest Consulting Pty Ltd	
Job – L10776g	Drawn by: AR from Cabonne Council plan	Date: 25/3/2019

The subsurface properties were assessed by constructing 10 boreholes (BH1 to BH10). The borehole locations are outlined in Figure 1. The boreholes were constructed with a truck mounted drill rig and flight auger. The target depth of the borehole was 2m or drill refusal on rock.

Drill refusal on extremely high strength rock was encountered in the boreholes drilled on the southern section of George Street (BH5 and BH6) at depths from 0.4m to 0.8m. The rock is expected to be limestone. Limestone outcrops were observed approximately 10m east of the proposed alignment.

Shallow rock (extremely high strength) was encountered in boreholes BH4 and BH5 at depths from 0.4m. The rock is limestone with an estimated compressive strength of 50MPa. The rock is an excavation limitation.

Weathered rock was encountered in boreholes BH8 to BH10 (Park Street) at depths from 1.7m. The rock was very high strength with an estimated compressive strength of 30MPa. The rock may be an excavation limitation.
