CABONNE COUNCIL

MOLONG FLOOD STUDY

NOVEMBER 2023

DRAFT REPORT FOR PUBLIC EXHIBITION

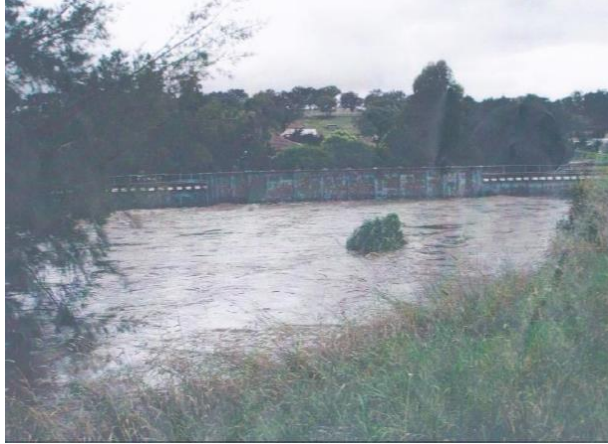
Plate C1.1 – (unknown time) Upstream side of Molong Creek Railway Bridge.

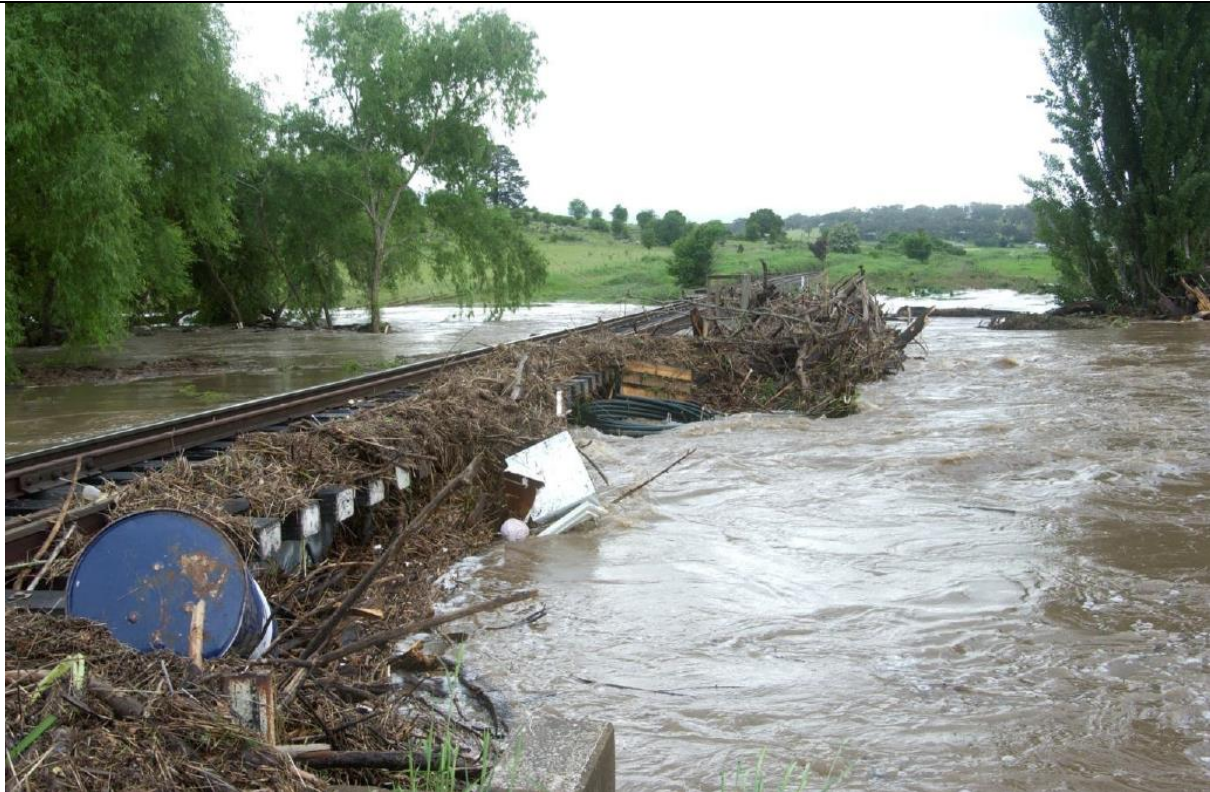
Plate C1.18 – (unknown time) Debris build up on the upstream side of the Molong Creek Railway Bridge.

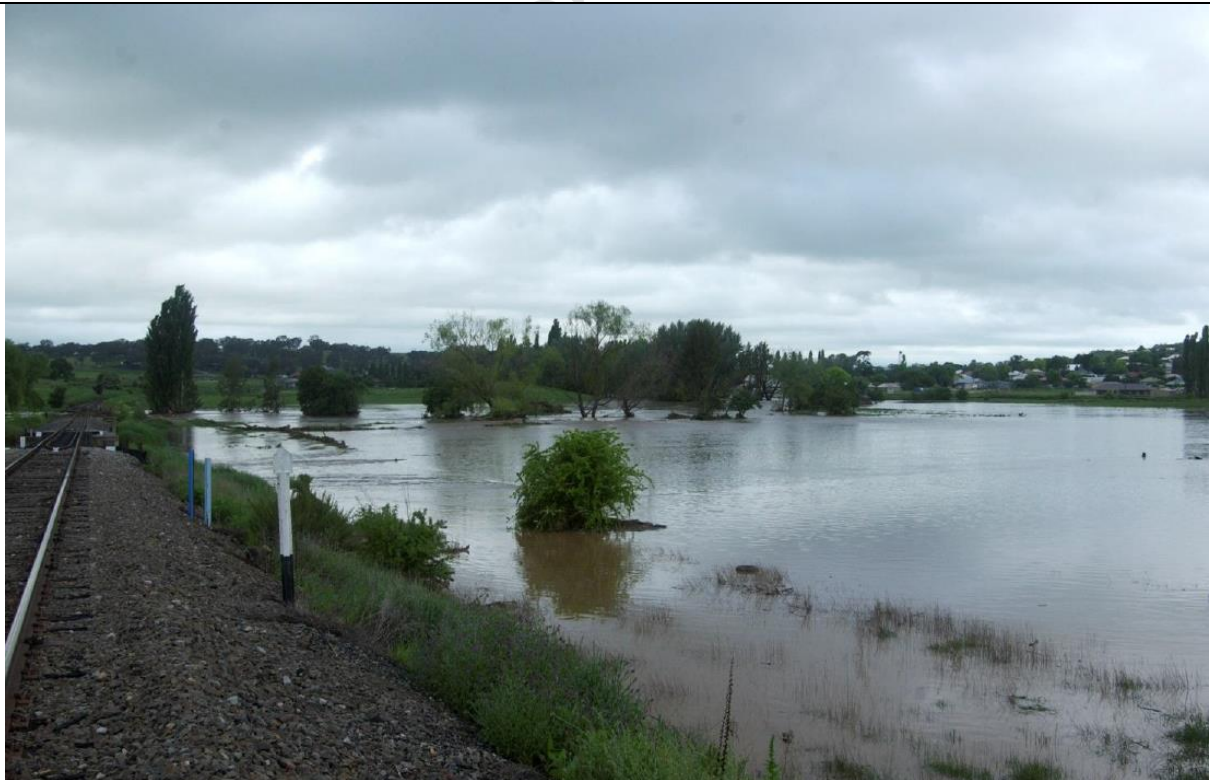
Plate C1.19 – (unknown time) Looking east along Molong Creek floodplain upstream of Broken Hill Railway.

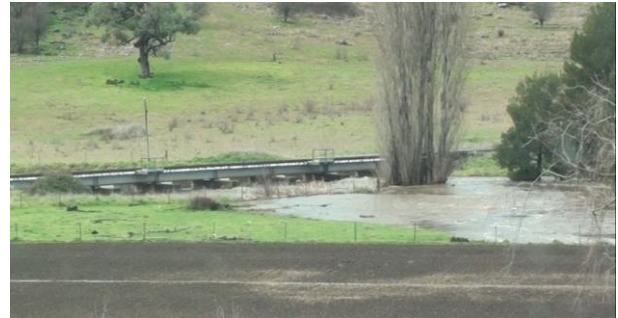
Plate C2.2 – (Photo taken at 13:00 hours) Broken Hill Railway Bridge No. 1 crossing of Molong Creek.

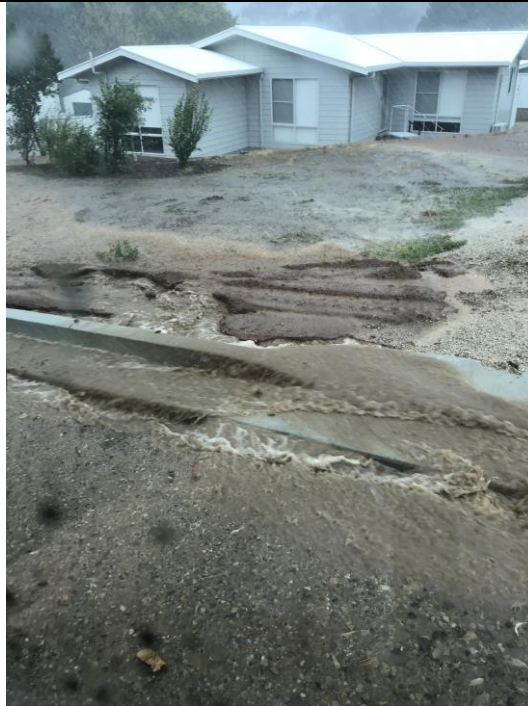
Plate C3.1 – (unknown time) Floodwater that surcharged Pillans Park Drainage Line at Pillans Park flowing in a northerly direction along the eastern side of Edward Street.

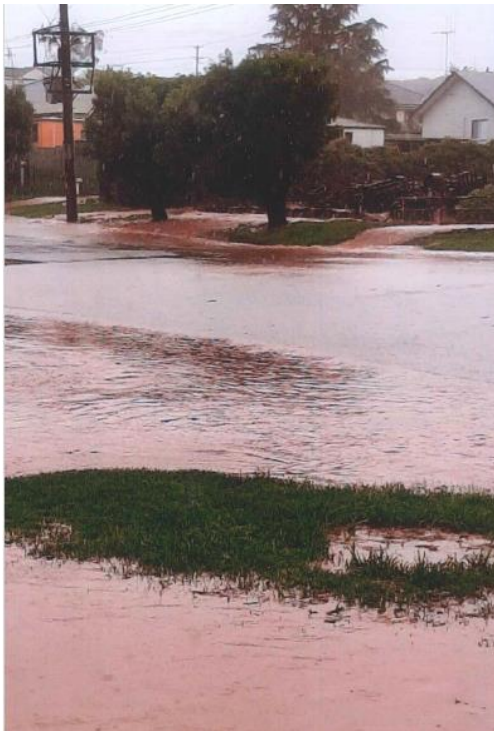
Plate C4.1 – (unknown time) Floodwater surcharging Pillans Park Drainage Line onto Gidley Street.

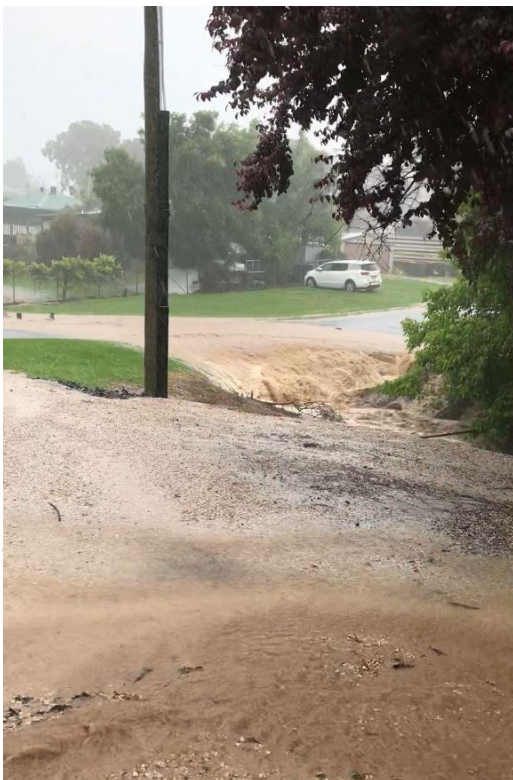
Plate C4.3 – (Photo taken at 15:35 hours) Lee Street crossing of Pillans Park Drainage Line.

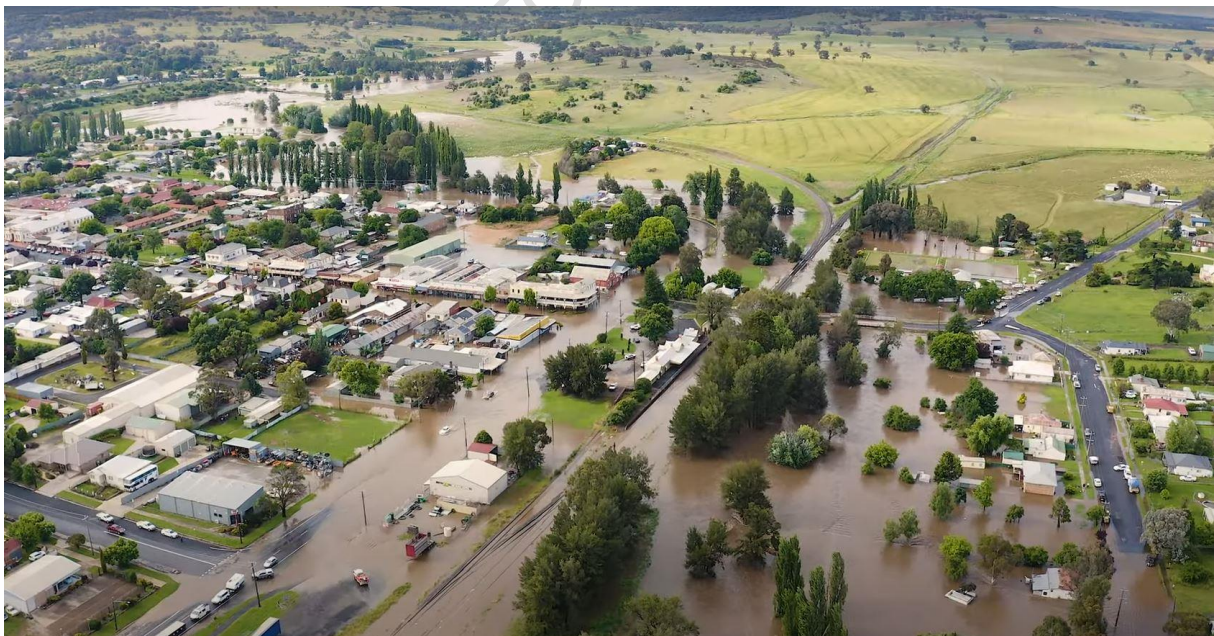
Plate C4.15 – (time unknown) Looking north along Molong Creek at Euchareena Road bridge.

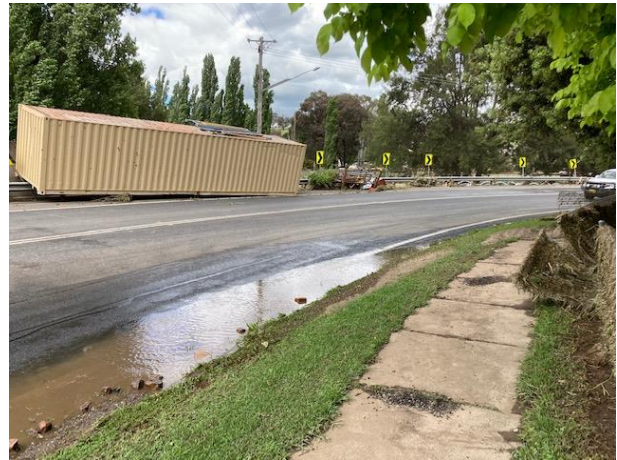
Plate C5.14 – (Photo taken at 14:30 hours) Debris left behind at the intersection of Watson Street and Hill Street.

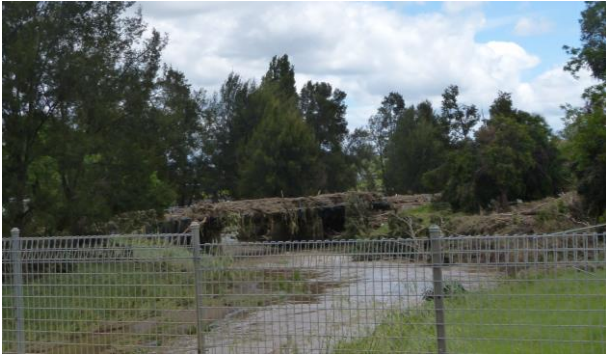
Plate C5.17 – (time unknown) Debris build-up on upstream side of Molong Creek Railway Bridge.

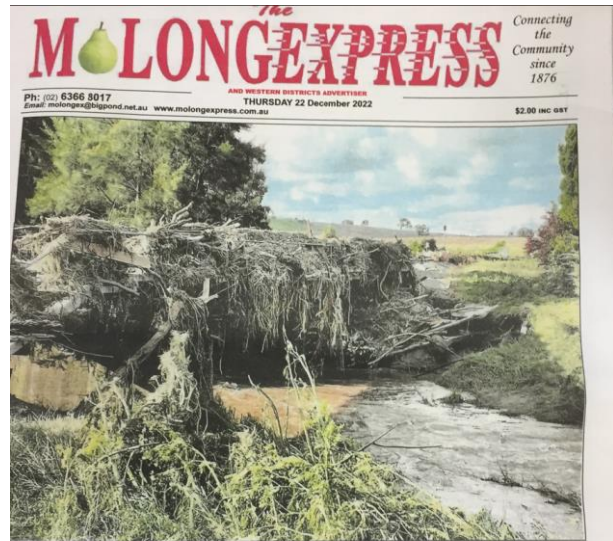
Molong Creek Railway Bridge

Plate C5.18 – Extract of Molong Express showing build-up of debris on upstream side of Molong Creek Railway Bridge.

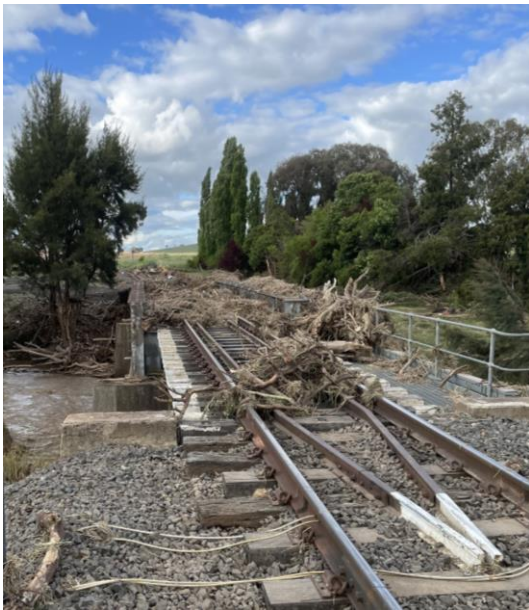
Plate C5.19 – (time unknown) Debris build-up on Molong Creek Railway Bridge.

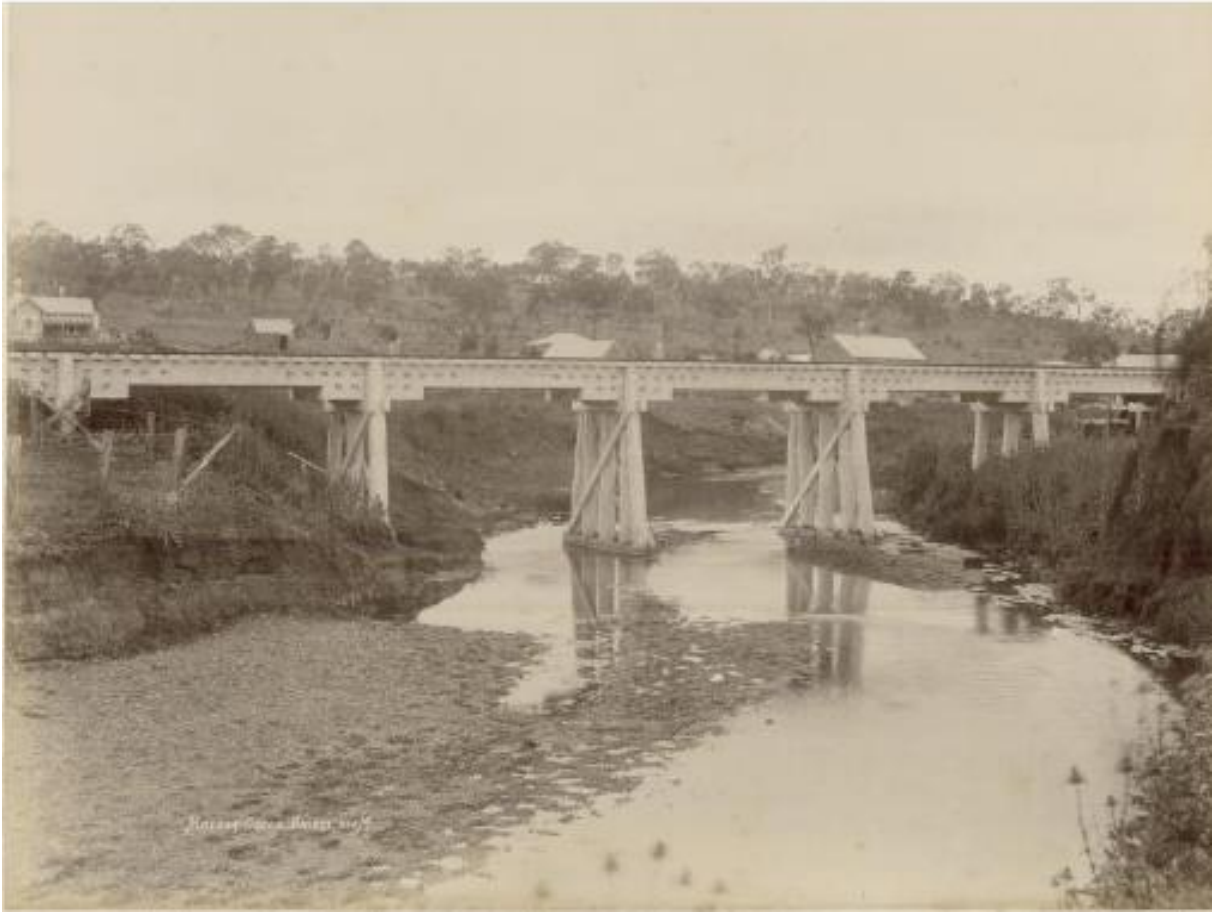
Plate C6.1 – Old Molong Creek Railway Bridge crossing of Molong Creek.
