Canomadine Creek Bridge

Geotechnical Investigation

Job No.: B21781

Cabonne Council – Canomadine Creek Bridge

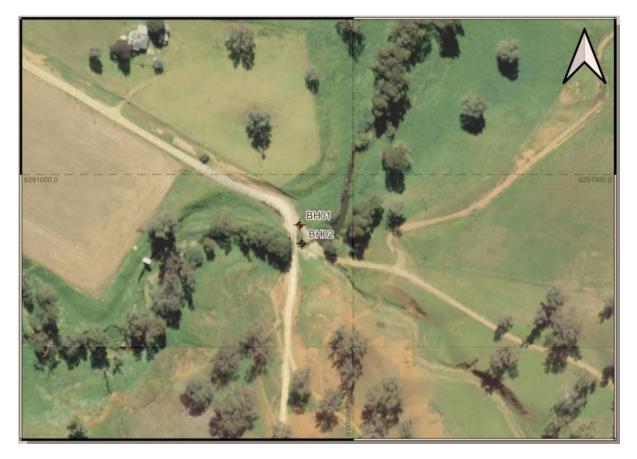
Figure 4: Borehole Location Plan

The boreholes were drilled at locations nominated by Macquarie Geotechnical and are summarised in Figure 4.

A track mounted Hanjin D&B 8D rig was used to drill two (2) boreholes to depths of up to 13.34m. Drilling comprised of 115mm diameter solid flight auger and HQ3 coring. In-situ testing comprised of Standard Penetration Testing (SPT) at 1.50m intervals in each borehole and Pocket Penetrometer (PP) tests on SPT split spoon samples.

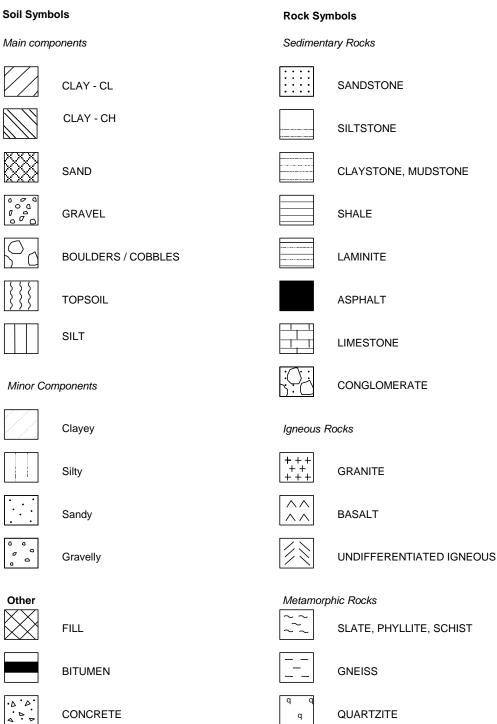
Typical symbols for soils and rocks are as follows. Combinations of these symbols may be used to indicated mixed materials such as clayey sand.

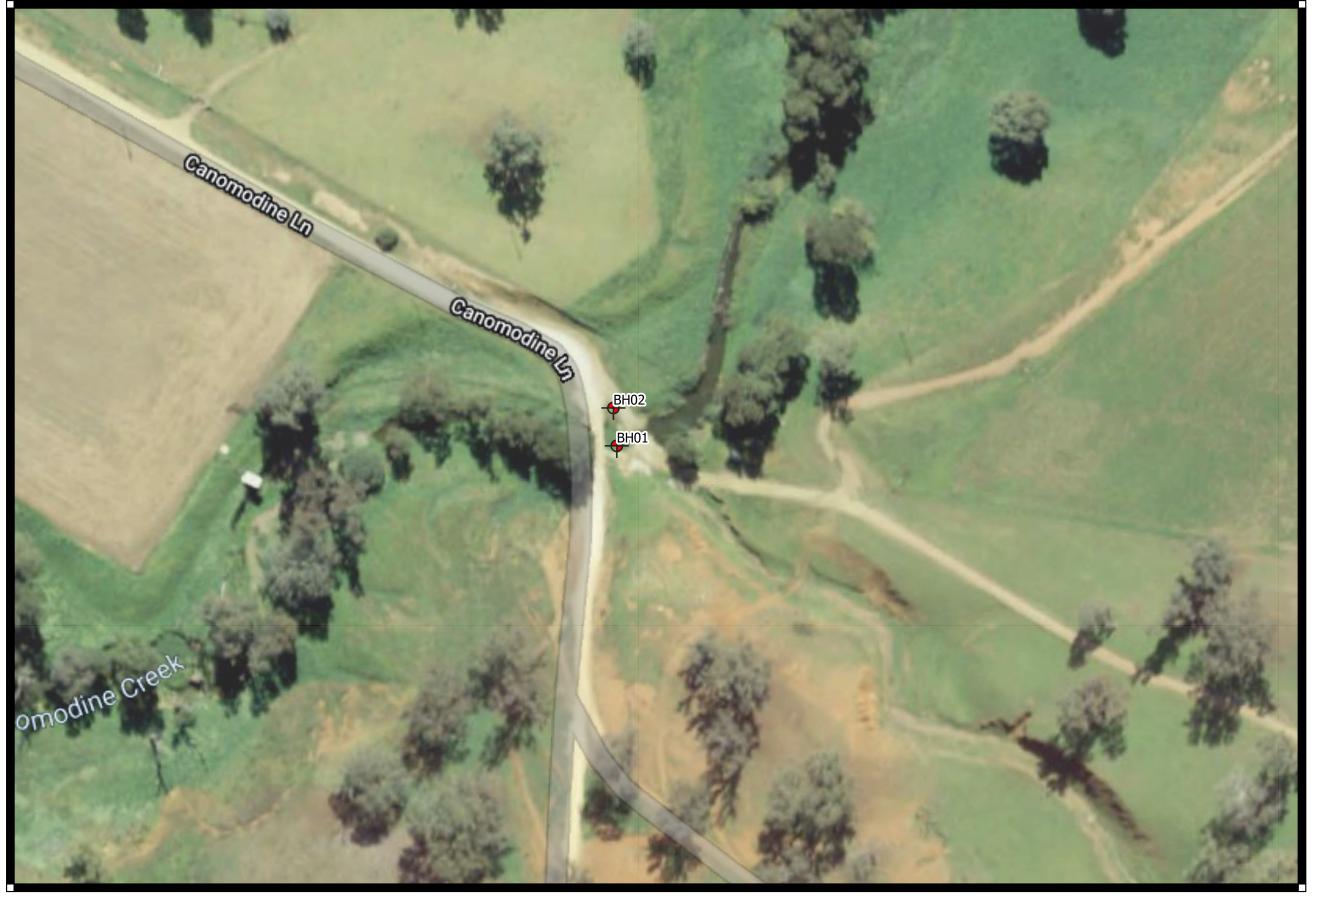
MACQUARIE	Client: Cabonne Council			0	20	40	60	80
	Project: Canomodine Bridge				Metres	- Scale	1:1,200	
GEOŢECH	Location: Canowindra, NSW				I to Horizonta			
3 Watt Drive, Bathurst NSW 2795 P: 02 6332 2011 F: 02 6334 4213 E: macgeo@macgeo.com.au	Drawn: CG	Checked: JB	Date: 30/4/2023	Co-ord	linate Referer	ice System	- EPSG: 432	26 WGS: 84
