Nyrang Bridge

Concept Options Design Report

Cabonne Council

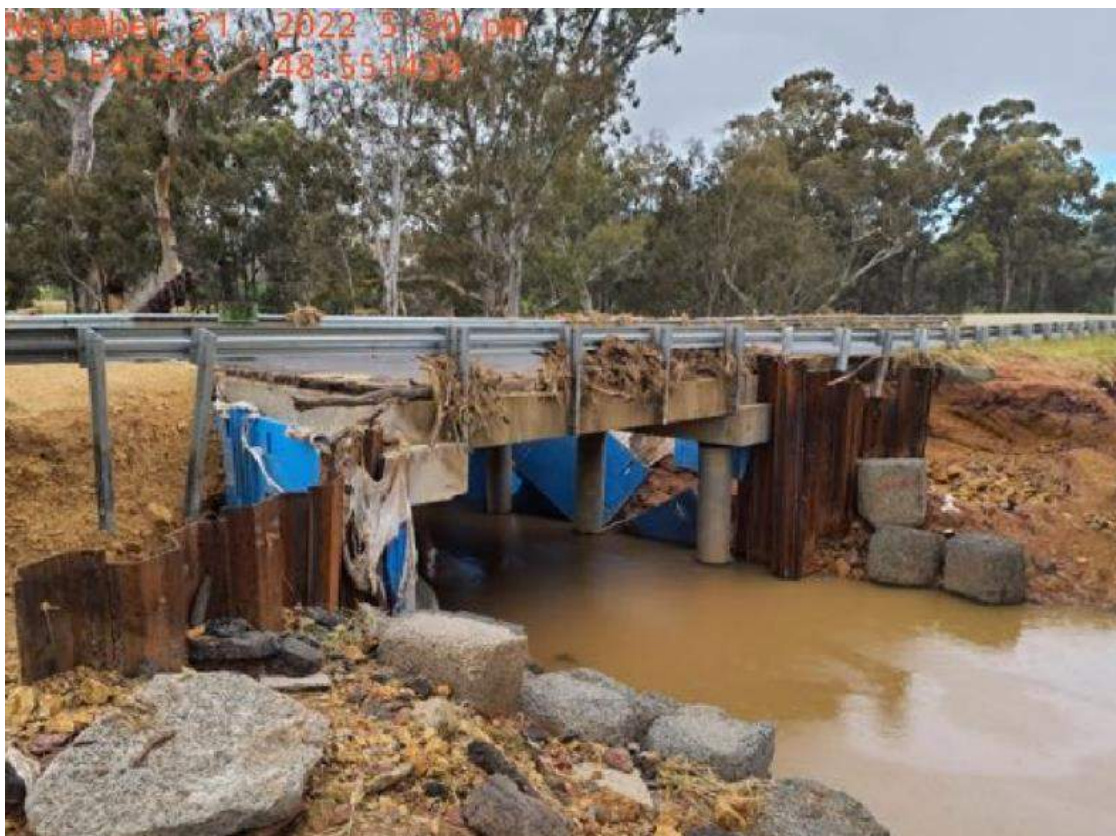
Figure 1 Temporary Repair of Bridge in 2022

Nyrang Bridge, along Nangar Rd approximately 10km west of Canowindra, which crosses Nyrang Creek (-33.541274 148.551453), had its abutments washed away during the floods of November 2021. It was a single span concrete bridge approximately 7.8 m long by 8.8 m wide. As this is a major route between Canowindra and Eugowra which otherwise requires a 50km detour, a temporary solution was quickly adopted by the council involving repairing the abutment with the installation of sheet piles and concrete blocks.

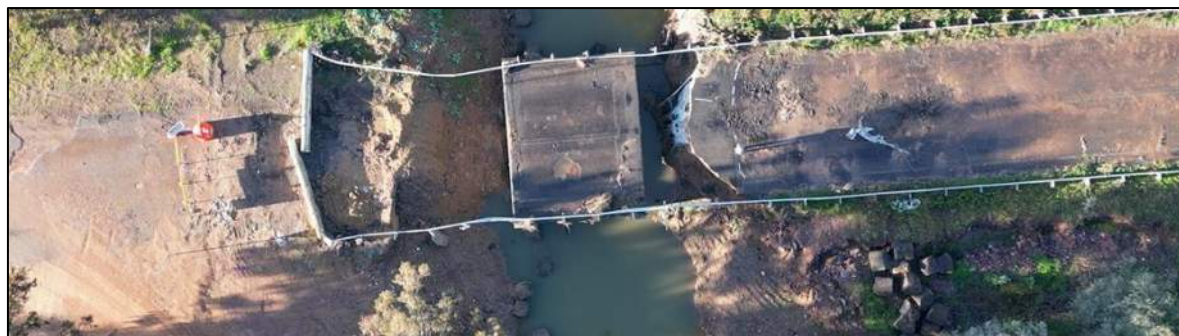
Figure 2 Existing Bridge Aerial View - approaches washed away.

This temporary solution was in place for about a year, until in November 2022 another bigger flood swept through the region and washed out the temporary works to a far greater extent than the earlier event. The bridge approaches are currently washed away, and the bridge has been closed to traffic. An unsealed sidetrack with a pipe culvert causeway has been installed to carry traffic while the bridge failure and repair is investigated (refer Figure 2)

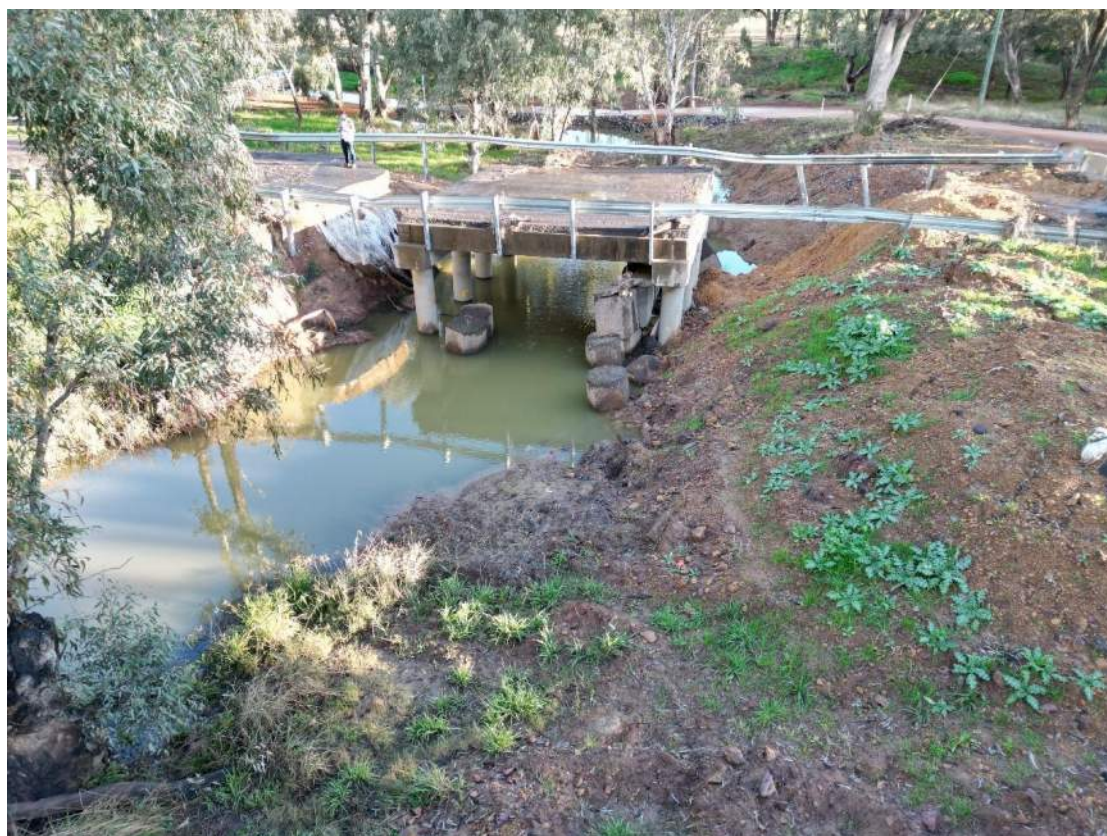
Figure 3 View from Upstream of existing bridge with washed away approaches.

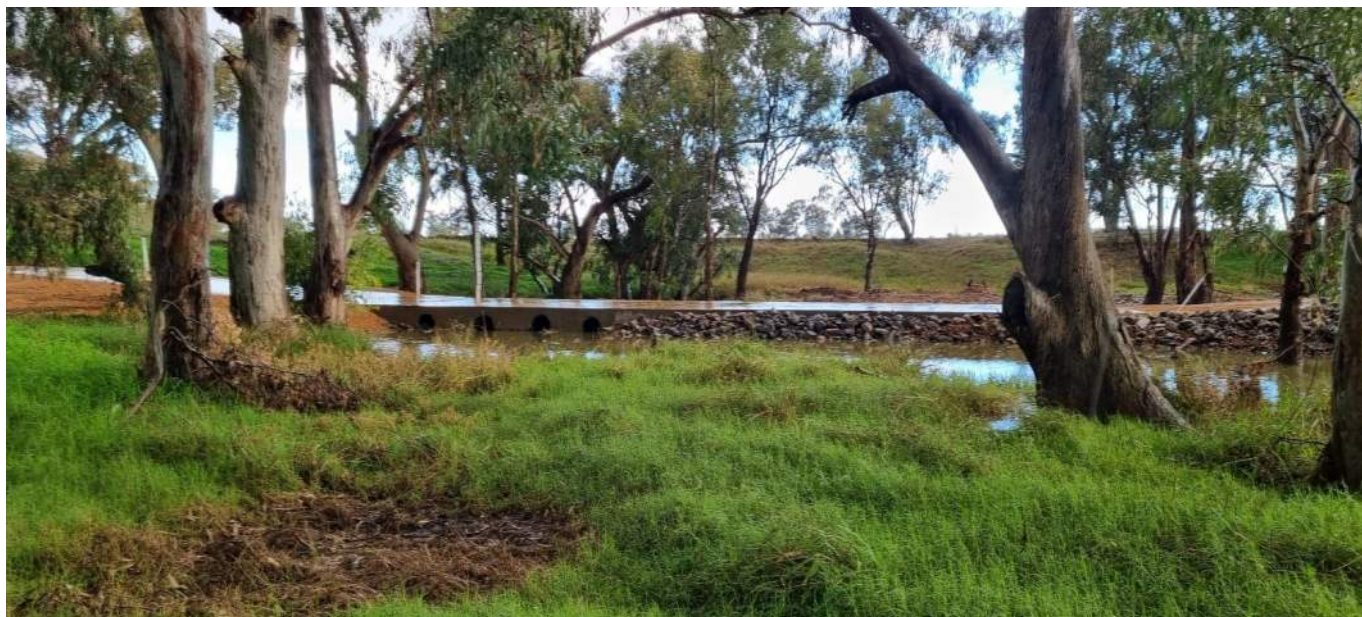
Figure 4 Temporary culvert-causeway sidetrack downstream from bridge

There is a temporary sidetrack that has been constructed currently carrying traffic – however this will certainly not survive the next flood and so will also be washed away in the short term. Long term use of the sidetrack is not feasible either, as traffic must slow down significantly to navigate the turns- it creates a hazard along the route from which there has already been several reported accidents and one fatality.

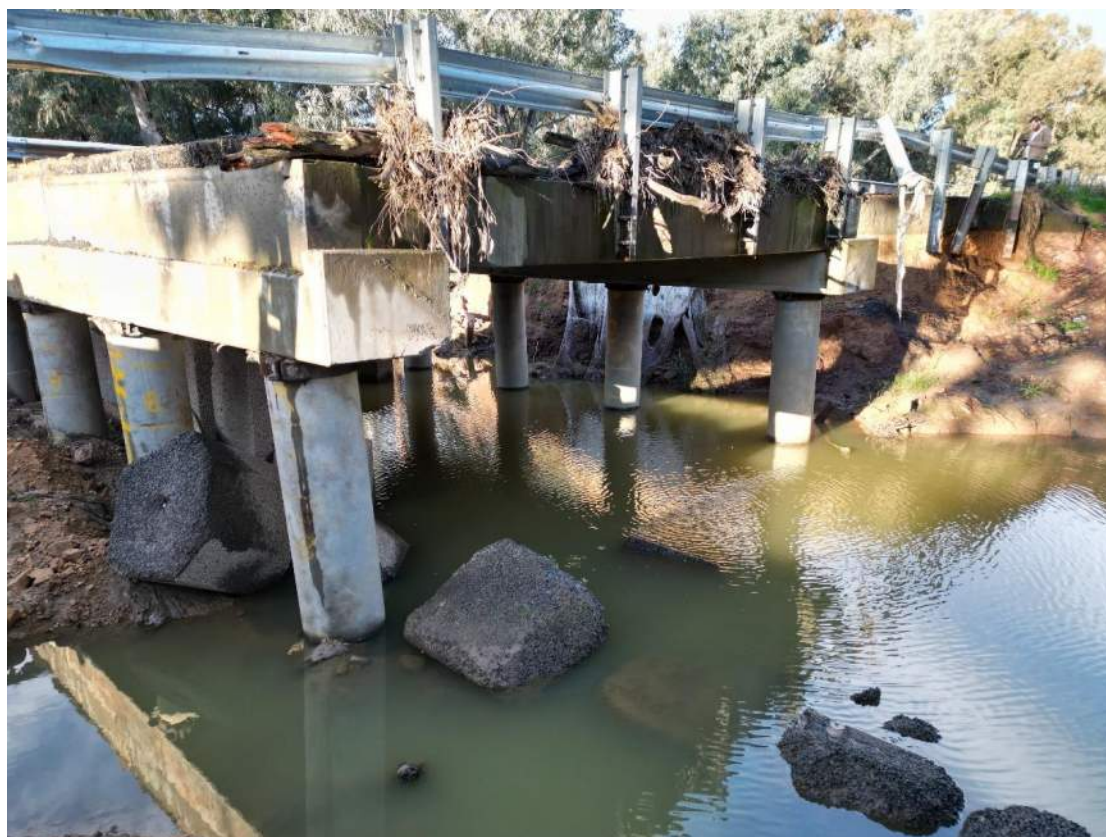
Figure 5 Concrete Block temporary abutment protection washed away.

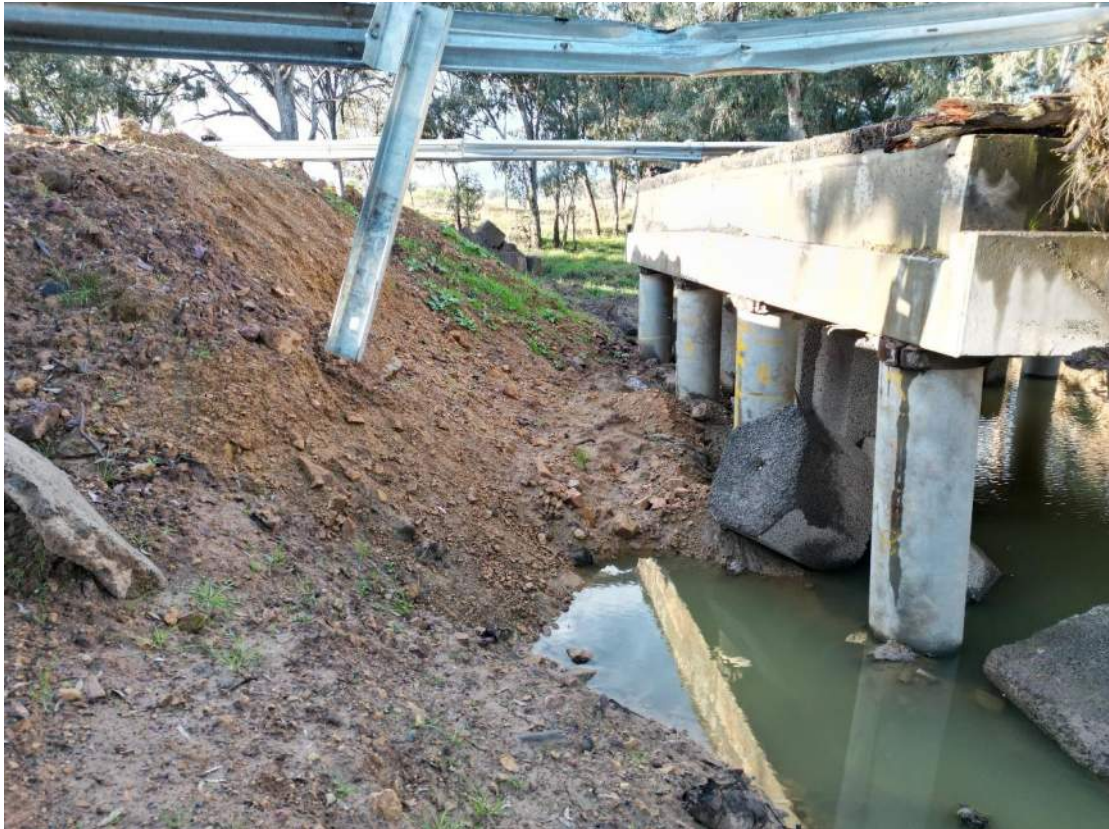
Figure 6 Significant Scour Behind abutments

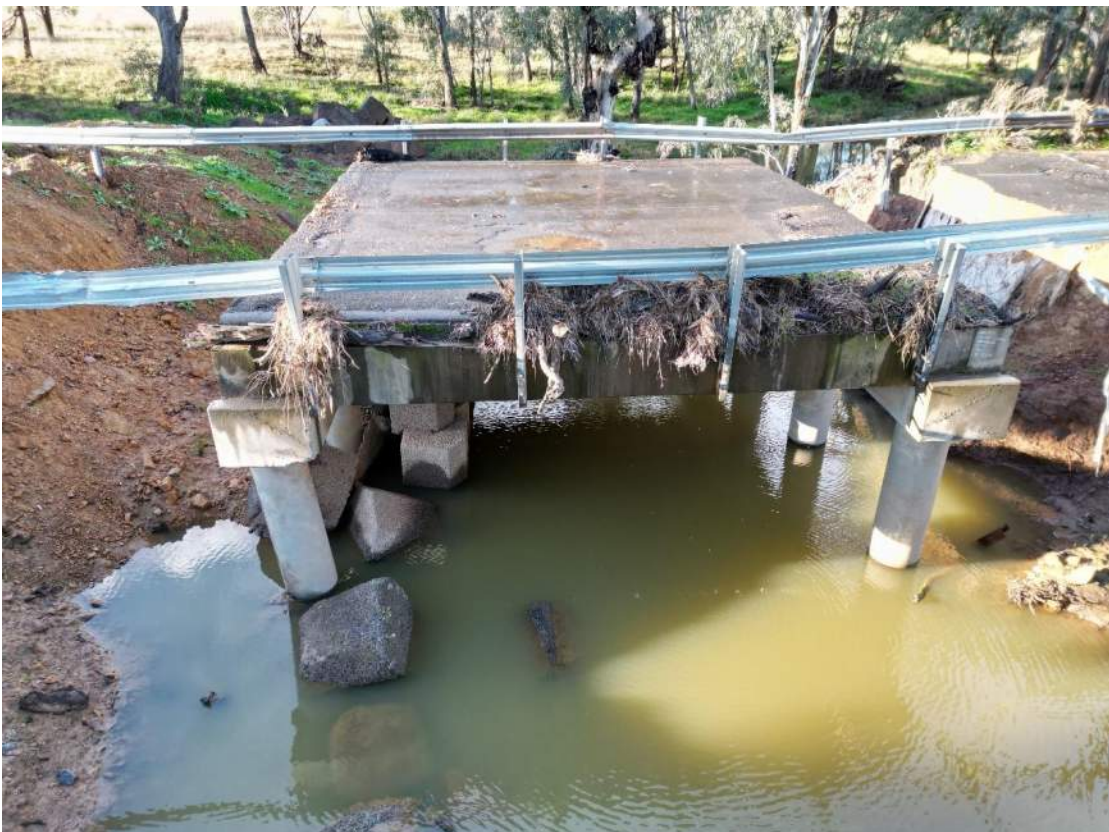
Figure 7 Looking upstream, significant debris evident.

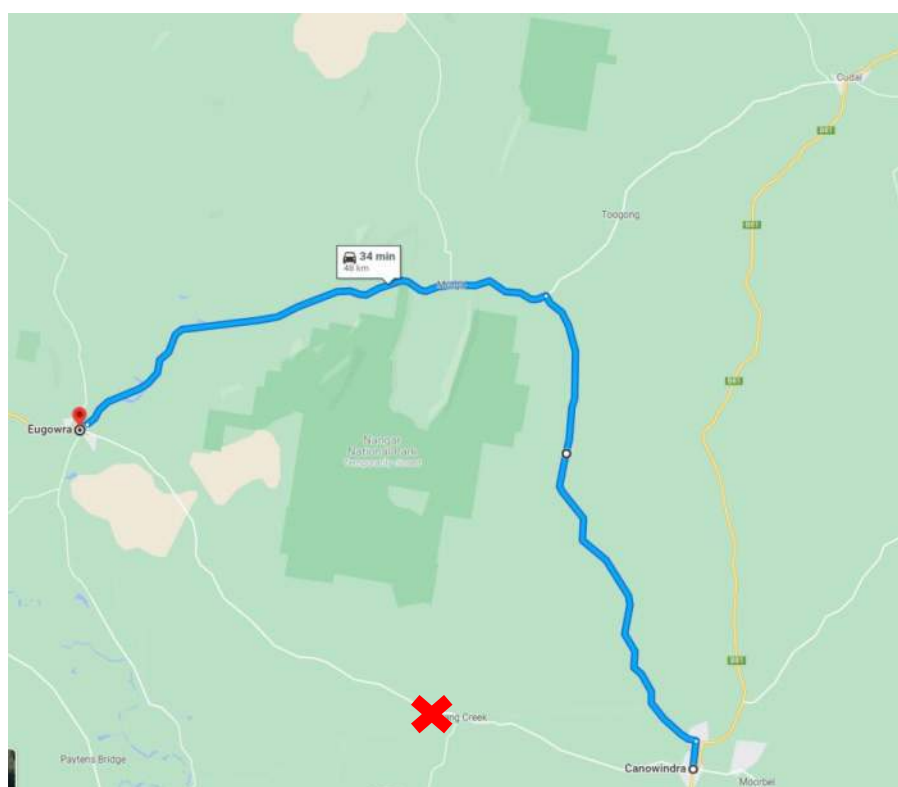
Figure 8 Alternative detour route

Eventually the road will be closed and if nothing is done, then a permanent detour route will need to be used to travel between Canowindra and Eugowra. Vehicles can travel northwest from Canowindra along Longs Corner Road to Eugowra via Murga, but this adds a further 14km and 10mins on the travel time. Longs Corner Road is a narrow local road between farm properties and is unsuitable for heavy vehicles; it will also become significantly damaged with more vehicles per day.

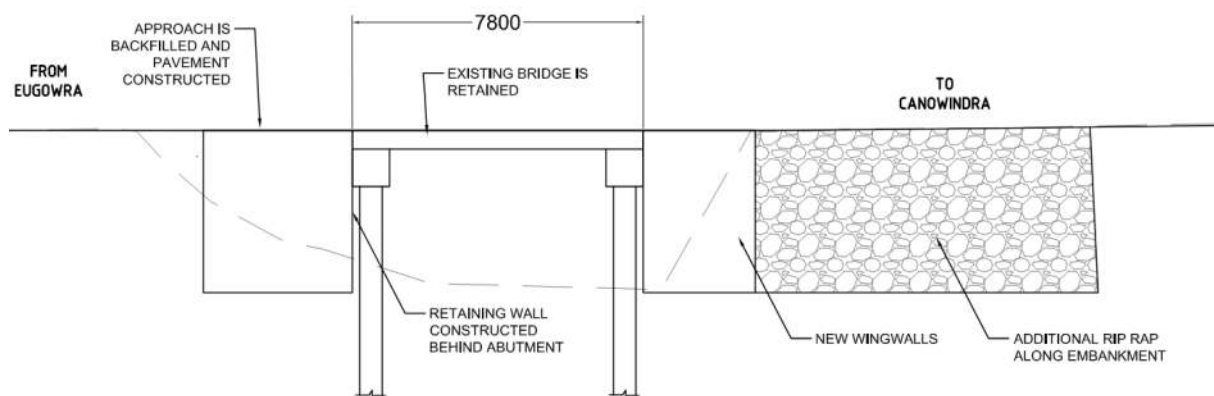
This option involves returning the bridge to its original 8m single span format by backfilling the abutments and resealing the road. This would be feasibly achieved by installing a retaining wall, either with concrete or steel sheet piles and then back filling with appropriately drained select fill. Wingwalls approximately 3.5m high will be required to contain this embankment and combat future scour. The cost of this construction would be relatively cheap in the short term – but in the long term may prove expensive in requiring replacement in the future.

Figure 10 Nyrang Bridge Concept Design Option 1

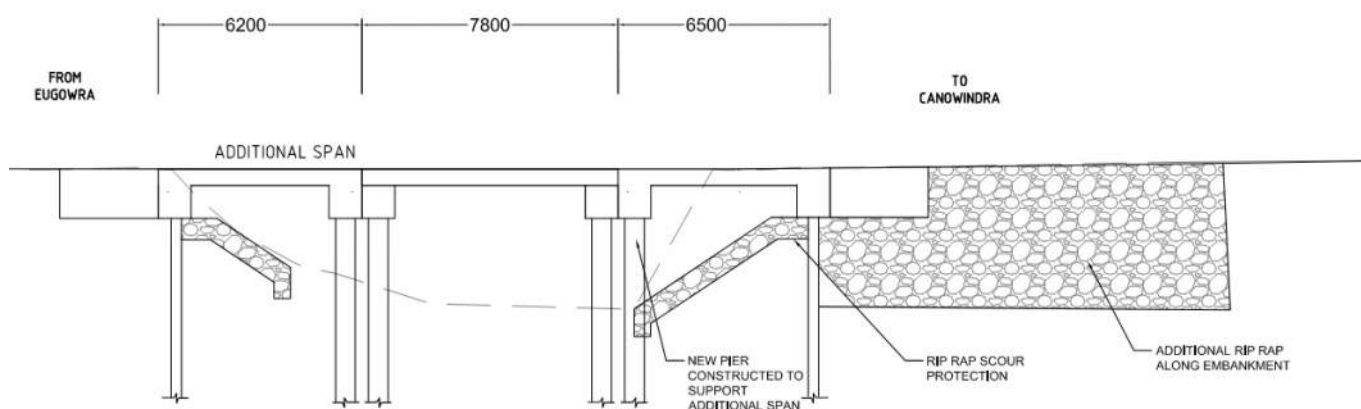
- The problem identified in Option 2 of having an old bridge with poor construction evident will reduce the life of the proposed solution. It is questionable whether the old bridge can withstand stronger floods and the capacity of the foundations is unknown.
- This option introduces the need for 2 additional piers and 2 abutments. This is practically building 2 separate bridges against an old bridge to make a 3-span structure. It will quickly become very expensive to design, build and maintain. This is because the headstocks of the existing bridge cannot easily support a new span without significant modification works.
- The piles supporting a new headstock would likely be driven piles which will look inconsistent compared to the existing bored piles.

Figure 11 Option 3 – New Spans constructed.

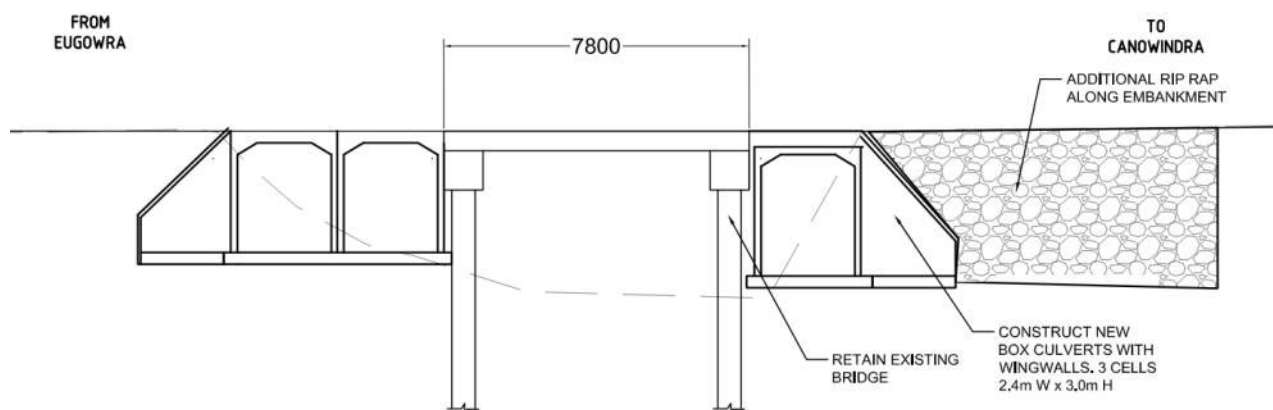
A slight alternative to Option 3 would be Option 3b – installing box culverts on base slabs as opposed to new bridge spans on piers.

Figure 12 - Option 3b - Box Culverts Used to extend bridge span.

However, culverts have recently gone up in price significantly and are no longer considered to be the ultra-cheap option they once were. Furthermore, the ground conditions at this site are very poor – soft clay at the creek bed which would need significant strengthening works to accommodate the bearing pressures of a culvert base slab. This would mean a bridging layer of rock below the base slab further adding to the cost of construction.

Lastly, Nyrang creek would be considered by Fisheries as a class 2 waterway with a moderate fish habitat as it is a *“Named permanent stream, with clearly defined bed and banks with semi-permanent to permanent waters in pools or in connected wetland areas. Marine or freshwater aquatic vegetation is present”*. This would immediately preclude the installation of box culverts without a significant justification in favour.

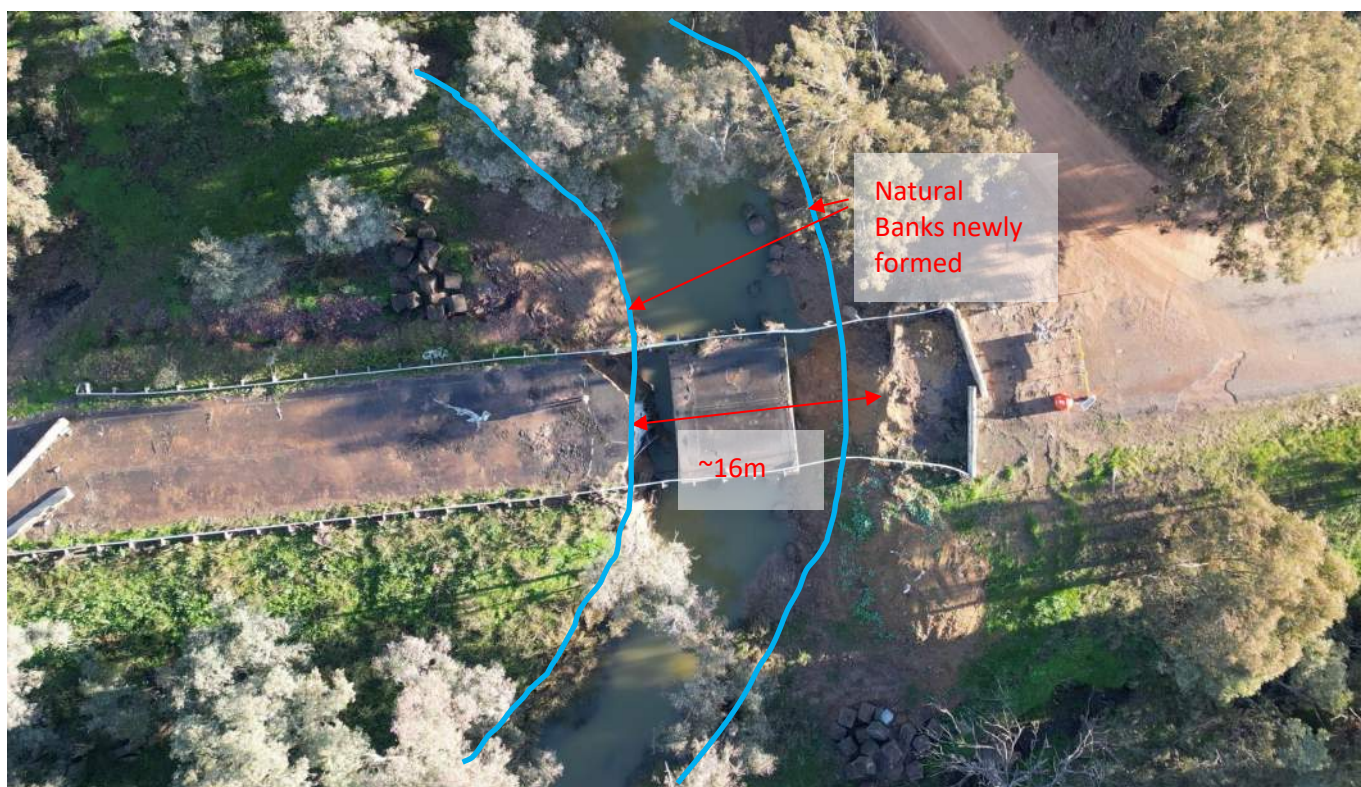
However, the natural erosion has opened up the distance between existing road to be around 16 m, which is shown in figure below. The new creek banks appear to fit well in this 16 m zone and with a 13 m bridge the scour rock protection would have constricted the waterway area. Therefore, it is recommended that a 16m bridge is adopted. This will convey more water during a flood and is a span that is still within the limits of standard precast planks, which are an affordable bridge option.

Figure 13 Natural Bank Lines and apparent 16m span

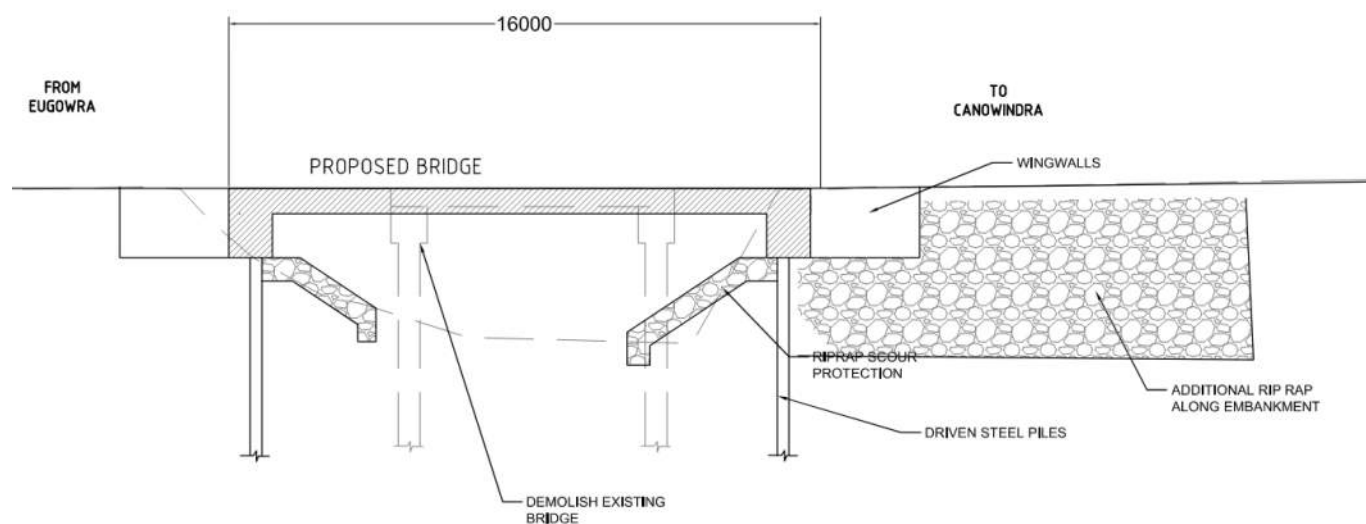
Option 4 therefore proposes to demolish the existing bridge and replace with an entirely new, single span bridge compliant to current standards. This will address the design life concerns of the other options, while also providing a properly designed structure suitable for the excessive flooding conditions that prevail in the area. This means it will be a solution designed to last 100 years and provide safe passage for all traffic, including heavy vehicles.

Figure 14 Nyrang Bridge Concept Design – Option 4

Considering the discussion above and the provided information in this report, it would appear that the most viable solution is to demolish the existing Nyrang bridge and replace with a new, fully compliant concrete bridge at approximately 16 m span x 9 m width with low performance barriers supported on driven pile foundations. Refer to Appendix D for concept design drawing.

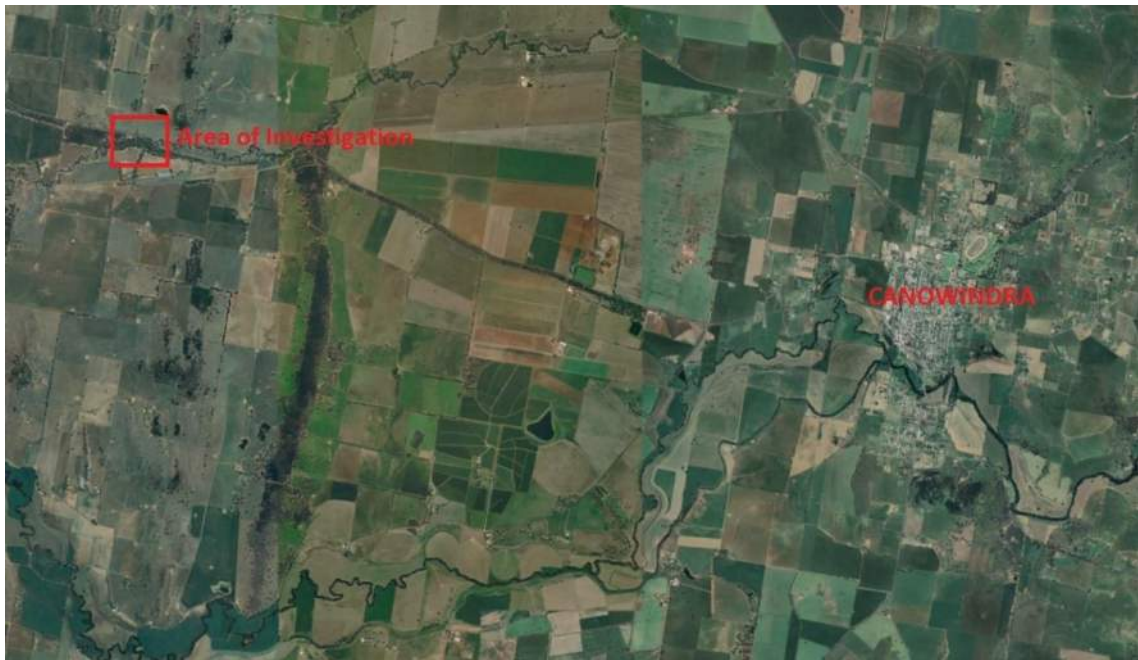
Plate 1 – Area of Investigation

Cabonne Council is planning to construct a new bridge over “Nyrang Creek” at Nyrang Creek NSW. The proposed site features that are covered by this investigation are as follows.

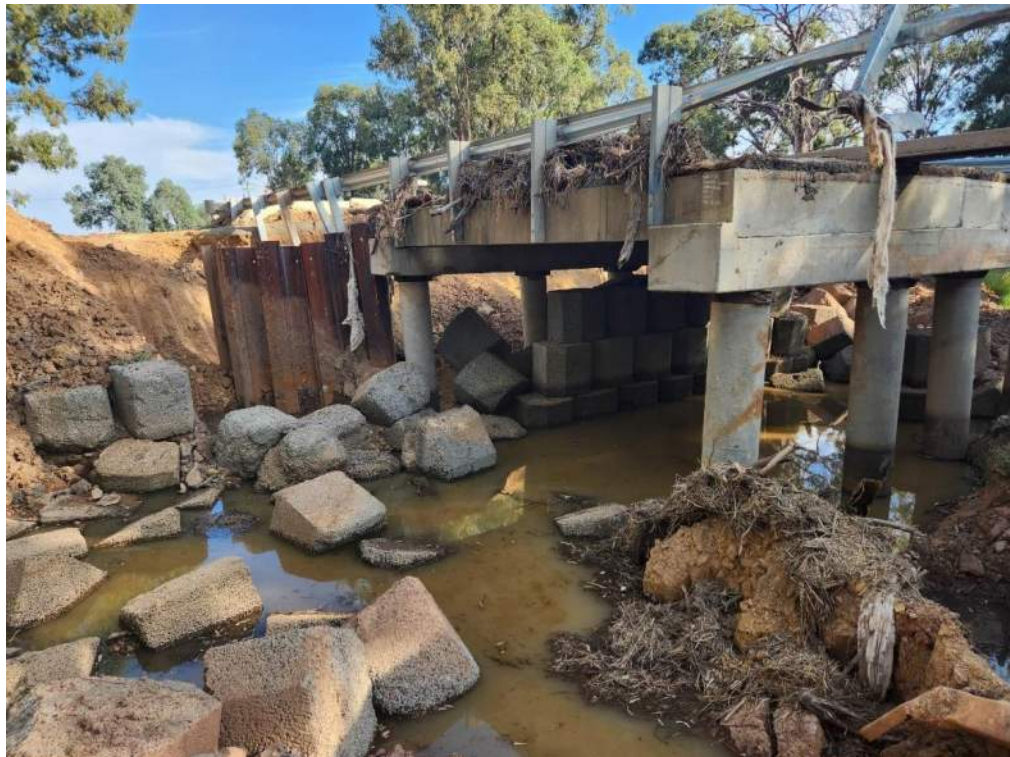
The current bridge has suffered severe flood damage due to water flows. It appears the water has severely scoured the soil behind the spill through abutments. It is therefore now clear that the span of the existing bridge was insufficient for the waterway area, and a new bridge of larger span is required.

Plate 2 – General view of site.

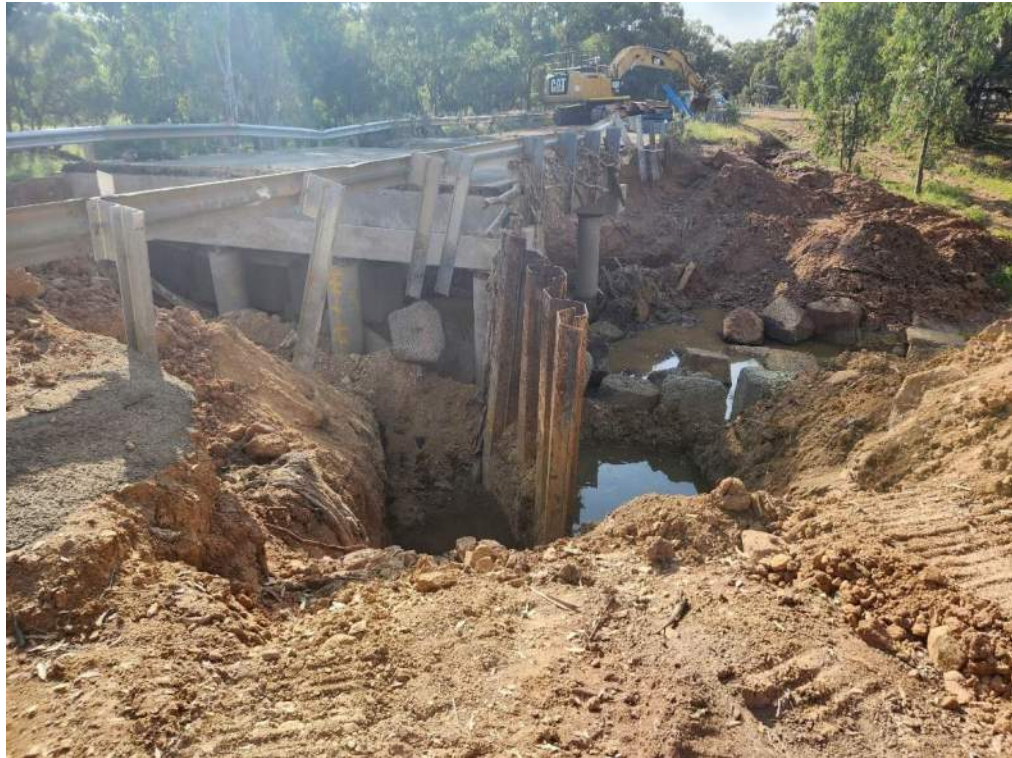
Plate 3 – General view facing east.

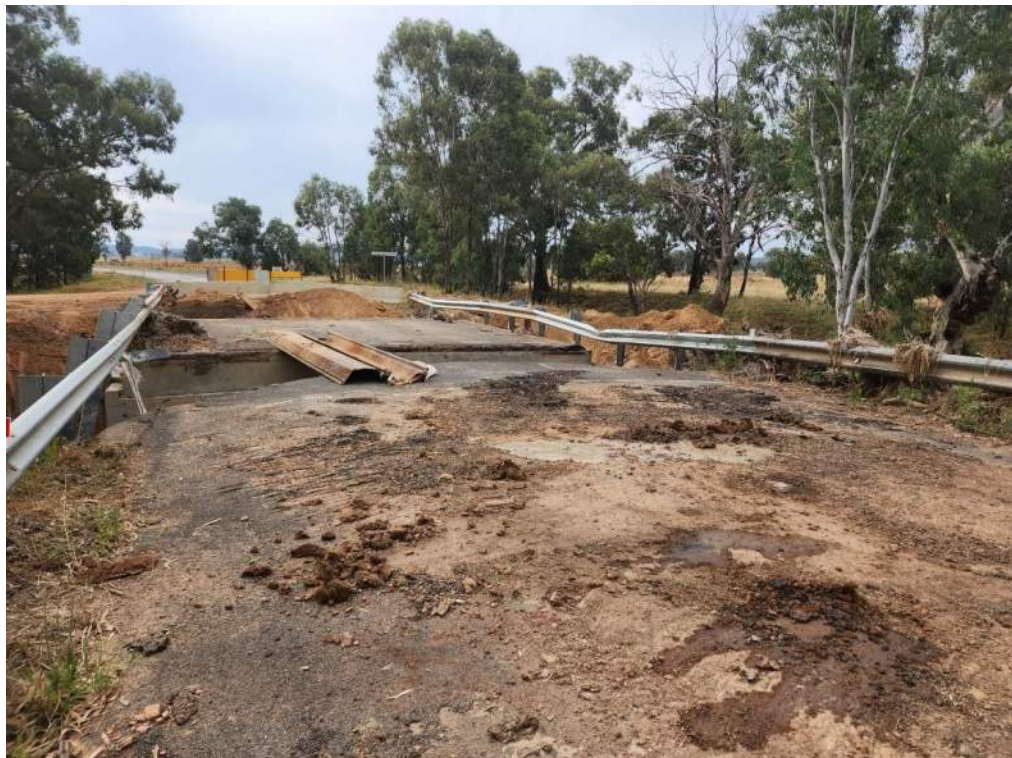
Plate 4 – General view of site facing west.

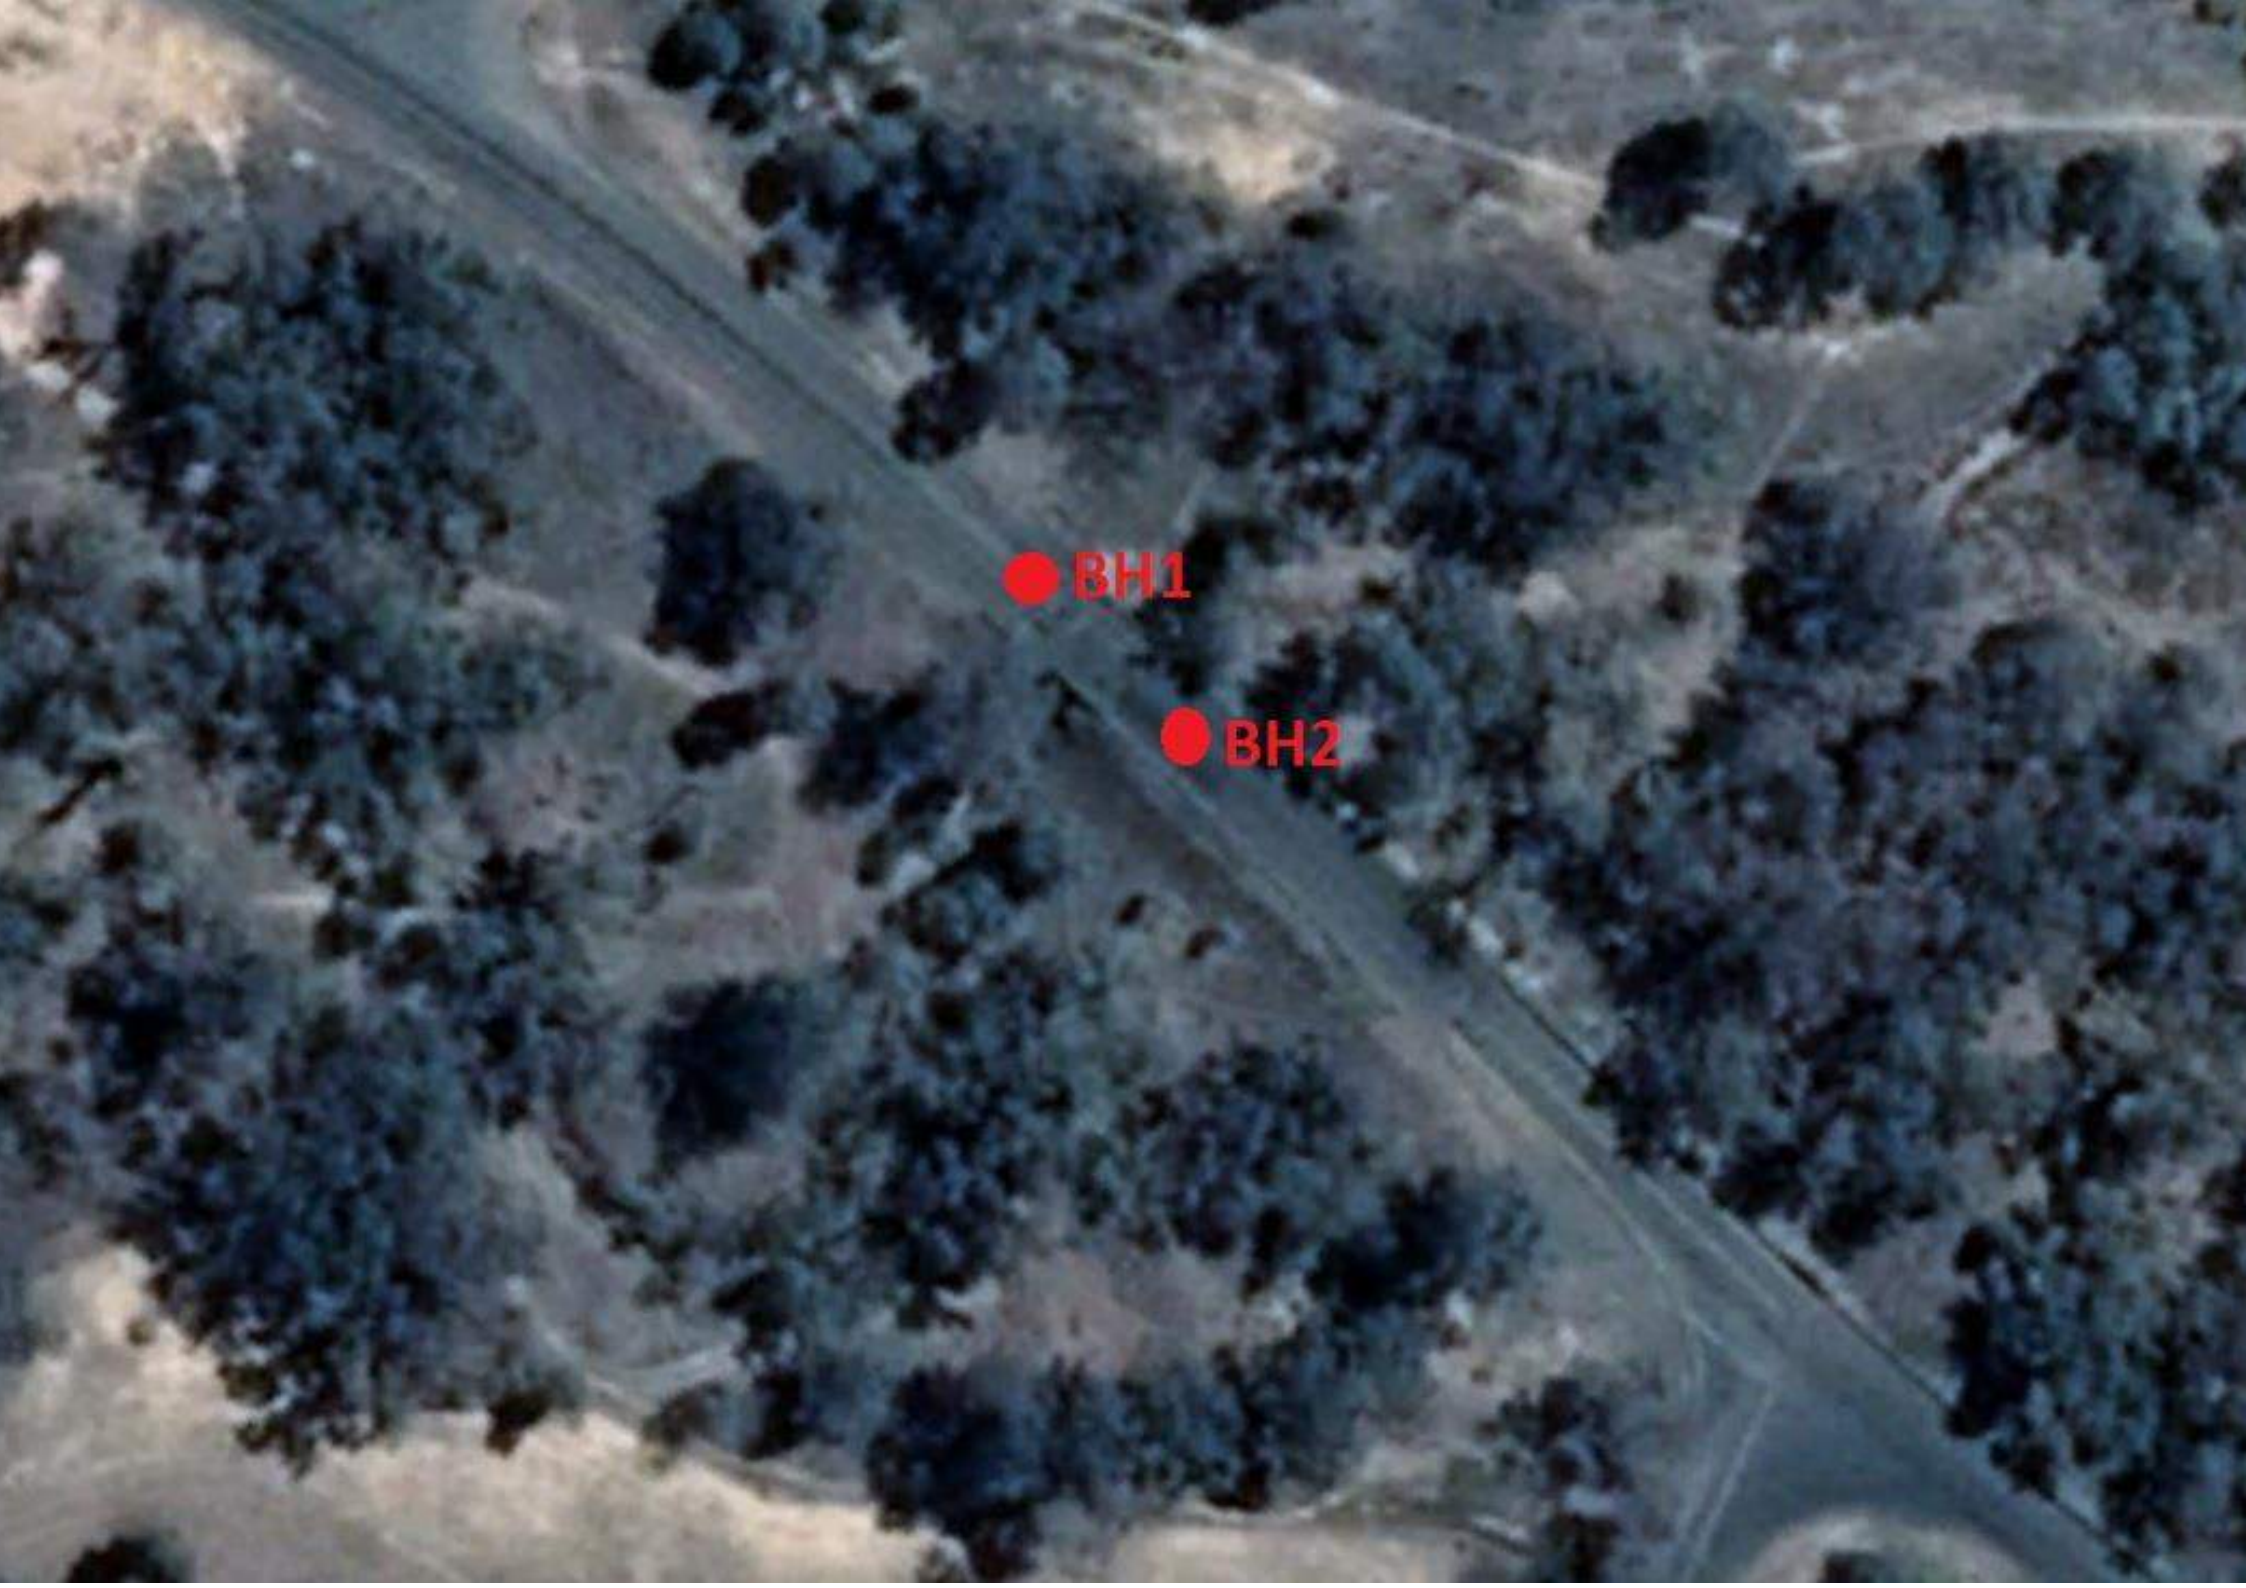
Appendix B - Site Plan with Borehole Locations

● BH1

● BH2

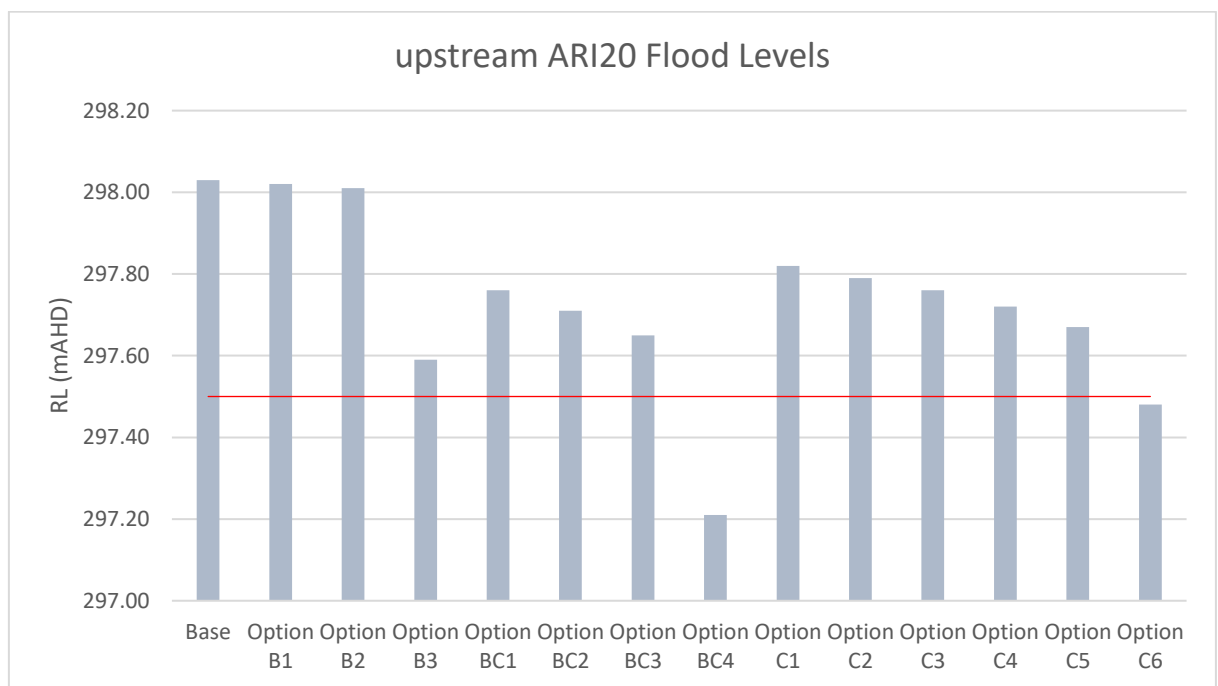
Figure 1 Flood Level Comparison of Options Considered

This red line indicates the level of the road and the figure indicates that during an ARI20 event the existing case is overtopped. A 13m bridge span greatly reduces the amount of water overtopping the bridge. Culverts restrict the flow unless a very large 4 cell culvert is build next to the existing bridge.

The flood modelling was also carried out considering various structural options including:

- B1: New Bridge at 9m
- B2: New Bridge at 11m
- B3: New Bridge at 13m
- BC1: Keep Existing bridge and add 1 Cell Culvert 2.4x2.4
- BC2: Keep Existing bridge and add 2 Cell culvert 2.4x2.4
- BC3: Keep Existing bridge and add 3 Cell culvert 2.4x2.4
- BC4: Keep Existing bridge and add 4 Cell culvert 2.4x2.4
- C1: Completely Replace with 3 Cell Culvert 2.4x2.4
- C2: Completely Replace with 4 Cell Culvert 2.4x2.4
- C3: Completely Replace with 5 Cell Culvert 2.4x2.4
- C4: Completely Replace with 6 Cell Culvert 2.4x2.4
- C5: Completely Replace with 7 Cell Culvert 2.4x2.4
- C6: Completely Replace with 8 Cell Culvert 2.4x2.4

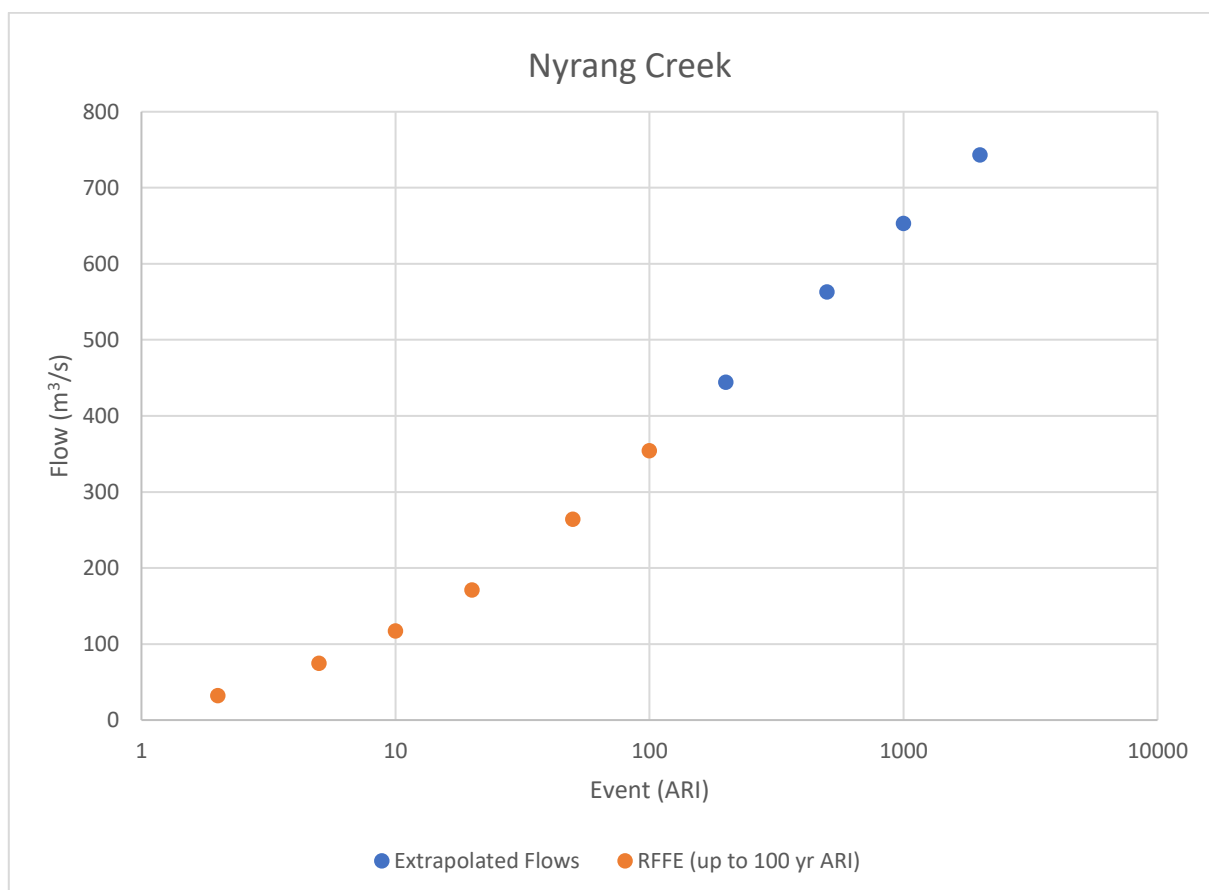
Flows for a range of events up to the 100-year ARI event were obtained from the RFFE Model 2015. The 50 and 100-year ARI events were then used to linearly extrapolate the flows up to the 2000-year ARI event. The flows are summarised in **Error! Reference source not found.** and are also illustrated in Figure 2.

Figure 2: Flows up to 100-year ARI and extrapolated flows up to 2000-year ARI

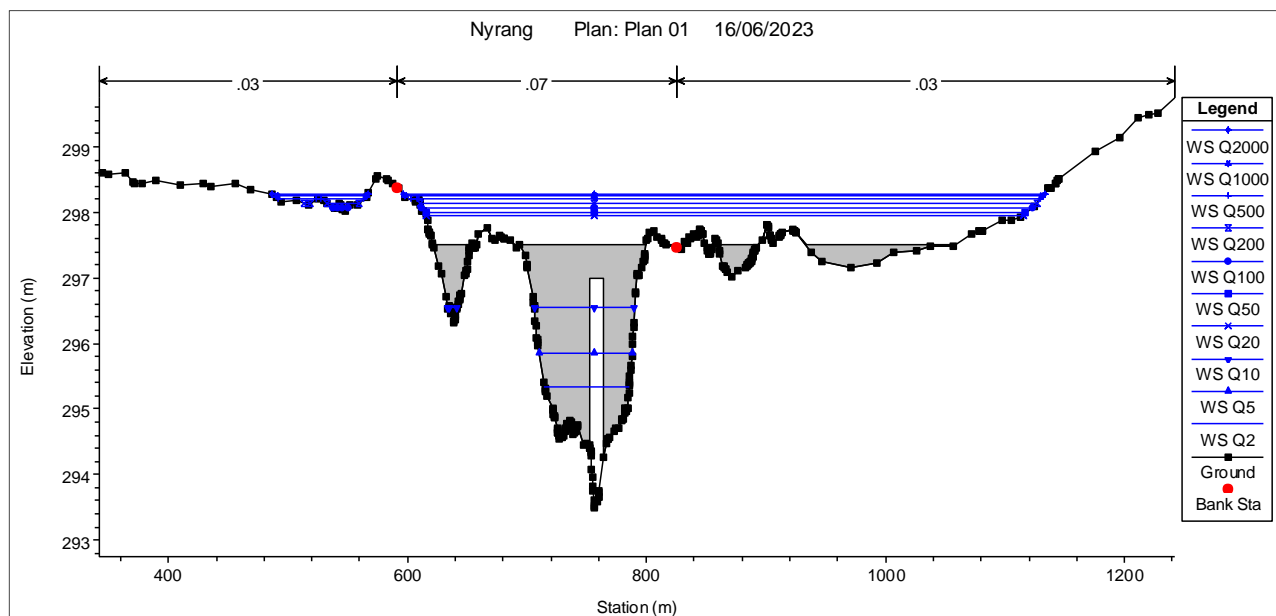
The cross-section at the bridge location is shown in Figure 3 which shows the flood levels for the modelled events and the long section of the bridge location is shown in Figure 4.

Figure 3: Cross-section showing flood levels

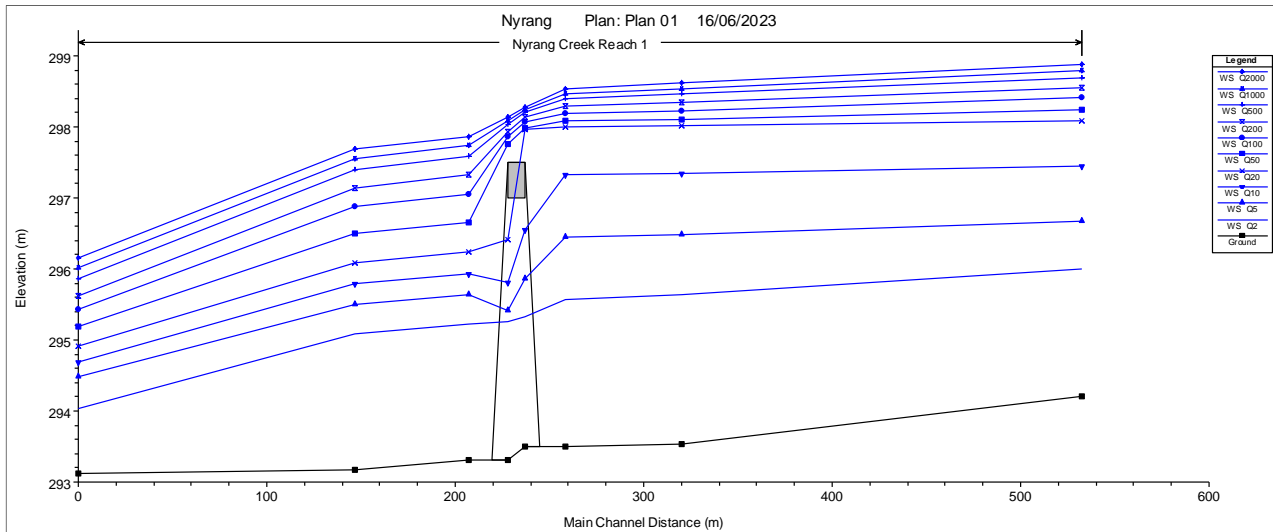
Figure 4: Long section showing flood levels
