Cabonne Shire Council – Constructive Energy  
Proposed Eugowra Wastewater Solar Farm  
Tom Griffiths  
Casuarina Drive  
Eugowra, NSW, 2806

**RE: Geophysical Resistance (Pull Out) Testing**

Following authorisation, a geophysical resistance (pull out) test was conducted across the proposed site for the Cabonne Shire Council proposed Eugowra Wastewater Solar Farm. The purpose of this testing was to gather the data required to assess the site's suitability for the installation of the Jurchen Tech PEG sub-frame as part of a PV array. Subject to geotechnical report and structural certification, the geophysical resistance testing conducted by Meralli indicates that the site is suitable for JT PEG. The information gathered will also be used to inform structural certification. Please find following our report.

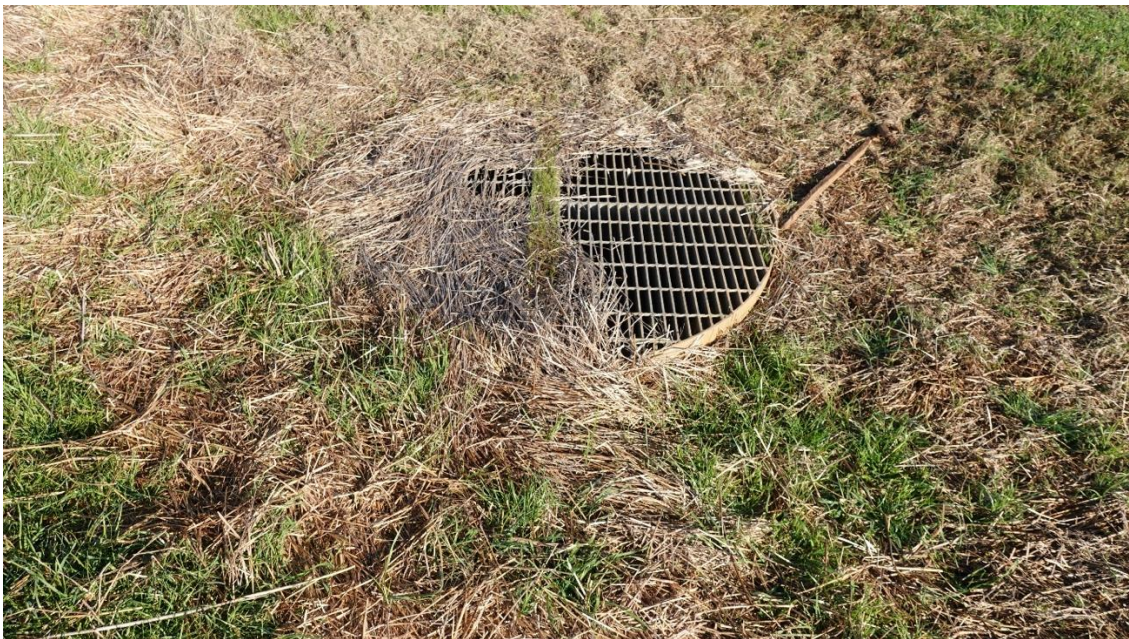
5 Drainage near meter box

Note underground electrical and water service in the vicinity of the proposed solar generator.

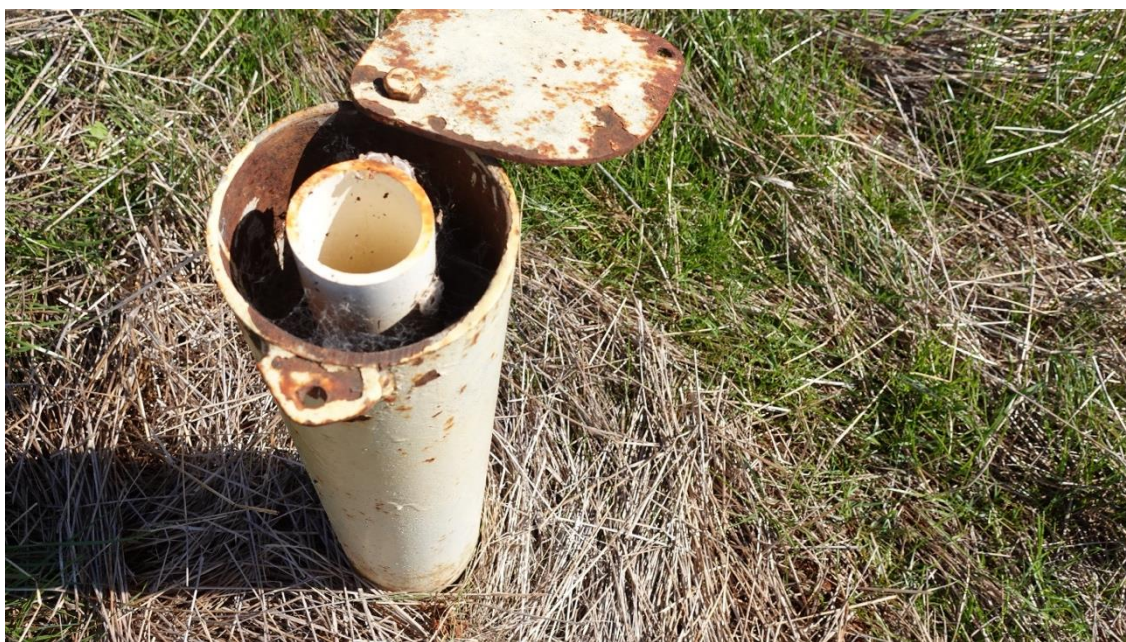
*7 Peizometer*

Piezometers in the vicinity of the proposed solar generator.

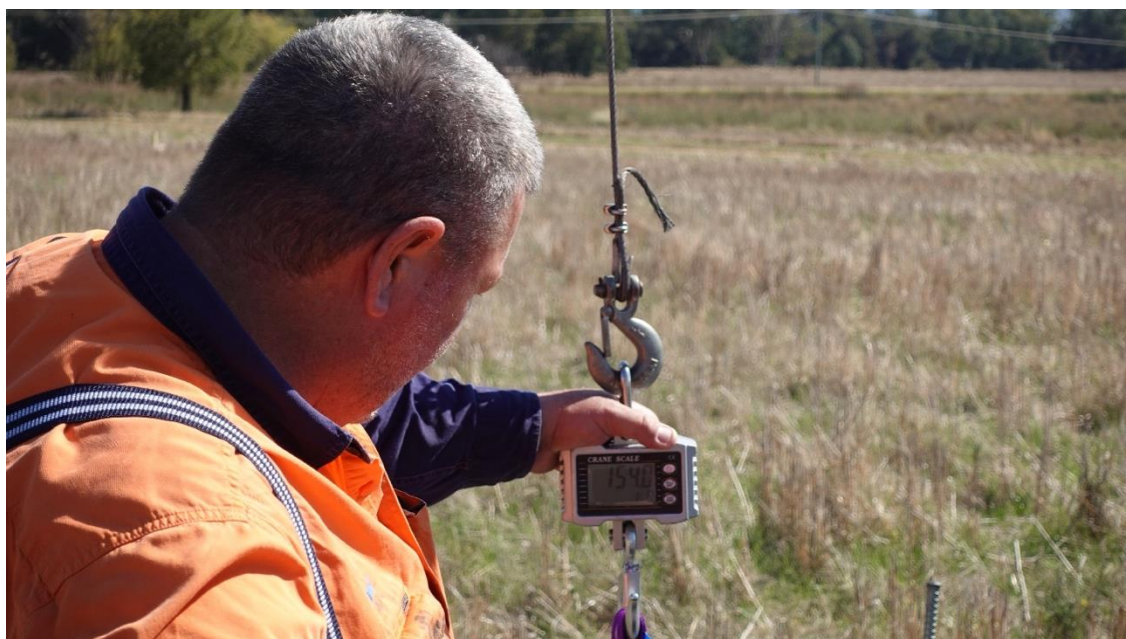
*8 Crane Scale*

The crane scale used had maximum limit of 1000kg.

Meralli Solar attended site on the 13<sup>th</sup> of April 2022 to conduct testing on the proposed area of the Eugowra Wastewater Solar Farm. Twenty-Four locations across the proposed site were tested. The testing procedure involves driving PEGs to four different nominated depths. A crane scale is then attached to the PEG and the tension required to shift the PEG is measured. The exact location, depth and tension is logged for each test.

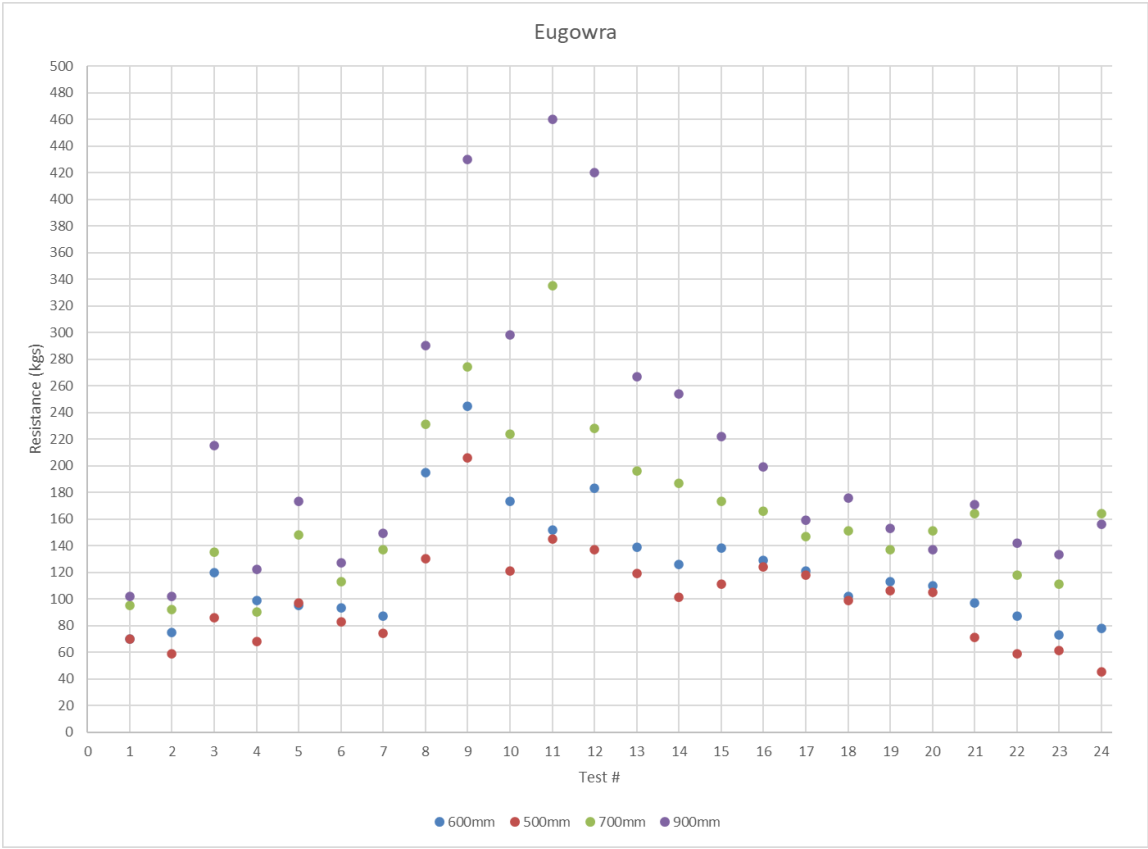
3.2 Graph

Test location		Test site	Depth (mm)			
			Resistance (kg)			
Latitude	Longitude	Test #	600mm	700mm	800mm	900mm
-33.448822	148.363289	1	70	70	95	102
-33.449009	148.363270	2	59	75	92	102
-33.449146	148.363310	3	86	120	135	215
-33.449298	148.363297	4	68	99	90	122
-33.449491	148.363199	5	97	95	148	173
-33.449690	148.363096	6	83	93	113	127
-33.449875	148.362987	7	74	87	137	149
-33.440059	148.363116	8	130	195	231	290
-33.450105	148.363087	9	206	245	274	430
-33.450306	148.362901	10	121	173	224	298
-33.450331	148.363035	11	145	152	335	460
-33.450421	148.363117	12	137	183	228	420
-33.450702	148.363818	13	119	139	196	267
-33.450785	148.363720	14	101	126	187	254
-33.450578	148.363837	15	111	138	173	222
-33.450283	148.363952	16	124	129	166	199
-33.450004	148.363987	17	118	121	147	159
-33.449245	148.364003	18	99	102	151	176
-33.449502	148.364028	19	106	113	137	153
-33.449663	148.364154	20	105	110	151	137
-33.449542	148.364201	21	71	97	164	171

-33.449433	148.364222	22	59	87	118	142
-33.449205	148.364290	23	61	73	111	133
-33.449142	148.364245	24	45	78	164	156

The site soil does appear to be homogenous, although testing was variable running with the slope. The lower part of the slope had a lower geophysical soil tension.
