STATEMENT OF **ENVIRONMENTAL EFFECTS**

SERVICE STATION

**LOT 1 DP 852310
19-23 GASKILL STREET
CANOWINDRA NSW 2804**

CANOWINDRA PETROLEUM Pty Ltd

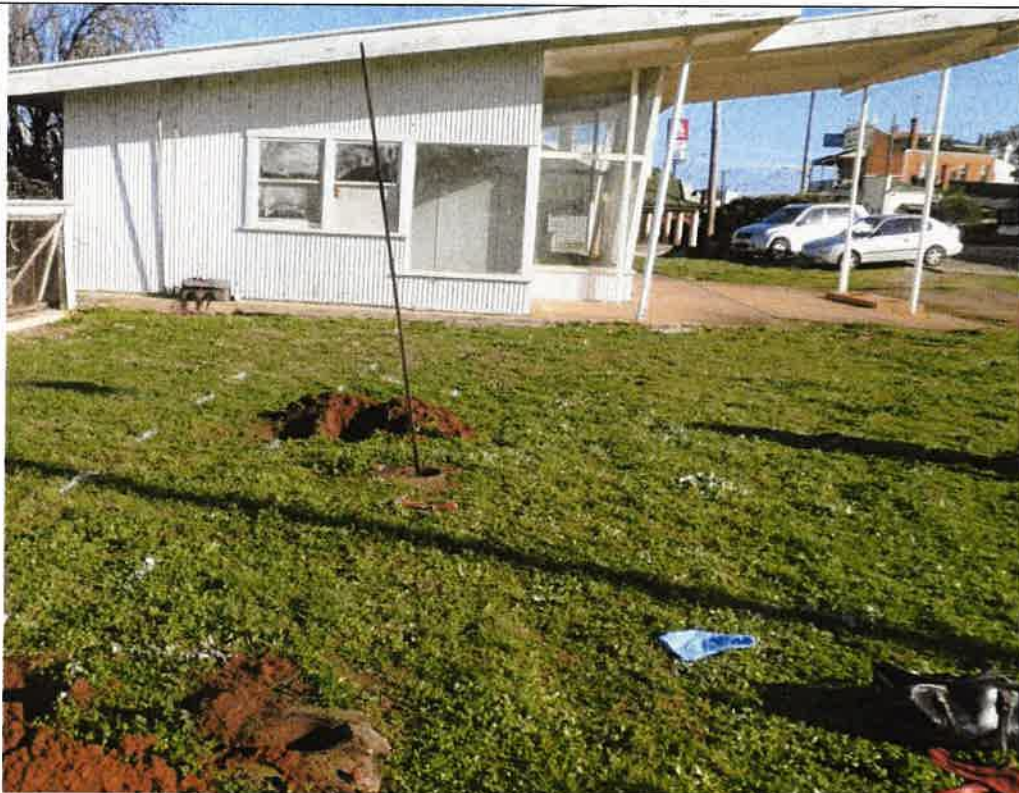
Plate 2 – Both dip/fill points opened, with the dip stick of tank 1 visible.

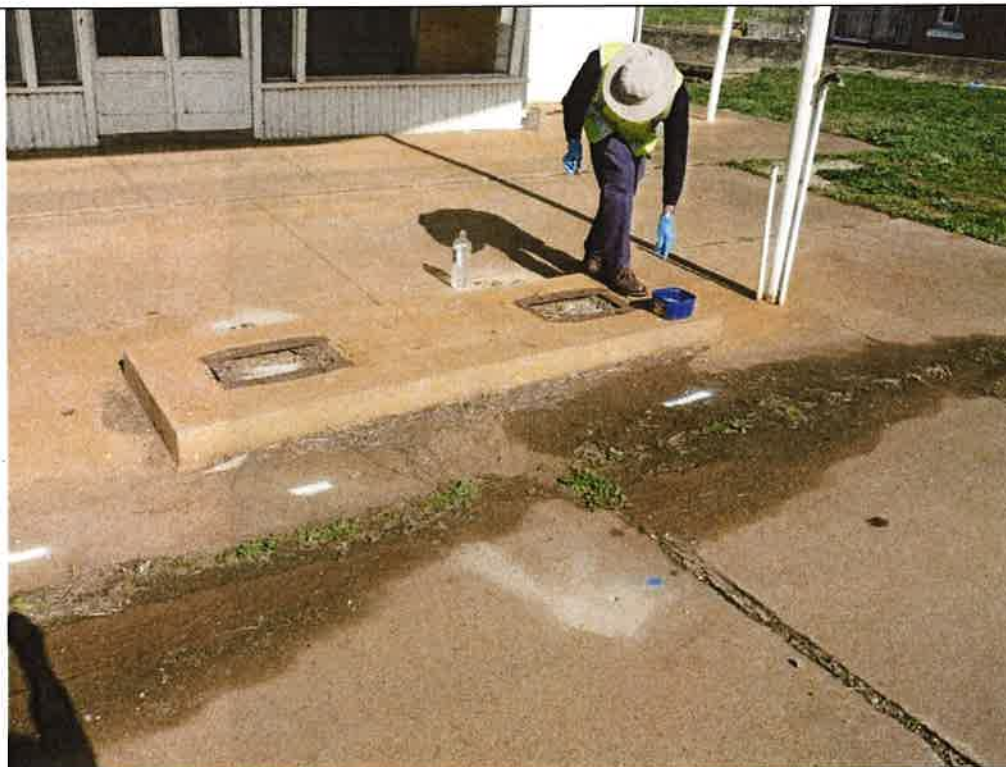
Plate 4 – The bowser island.

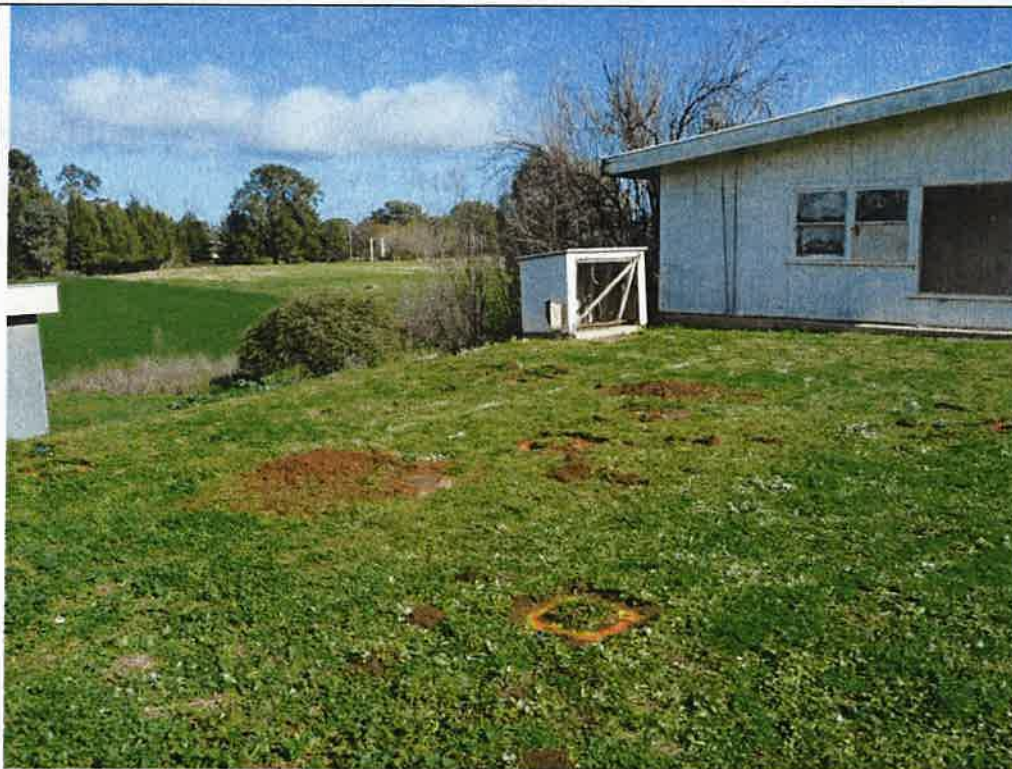
Plate 5 – Soil vapour sampling locations surrounding the underground fuel tanks. Note the two vent pipes on the building.

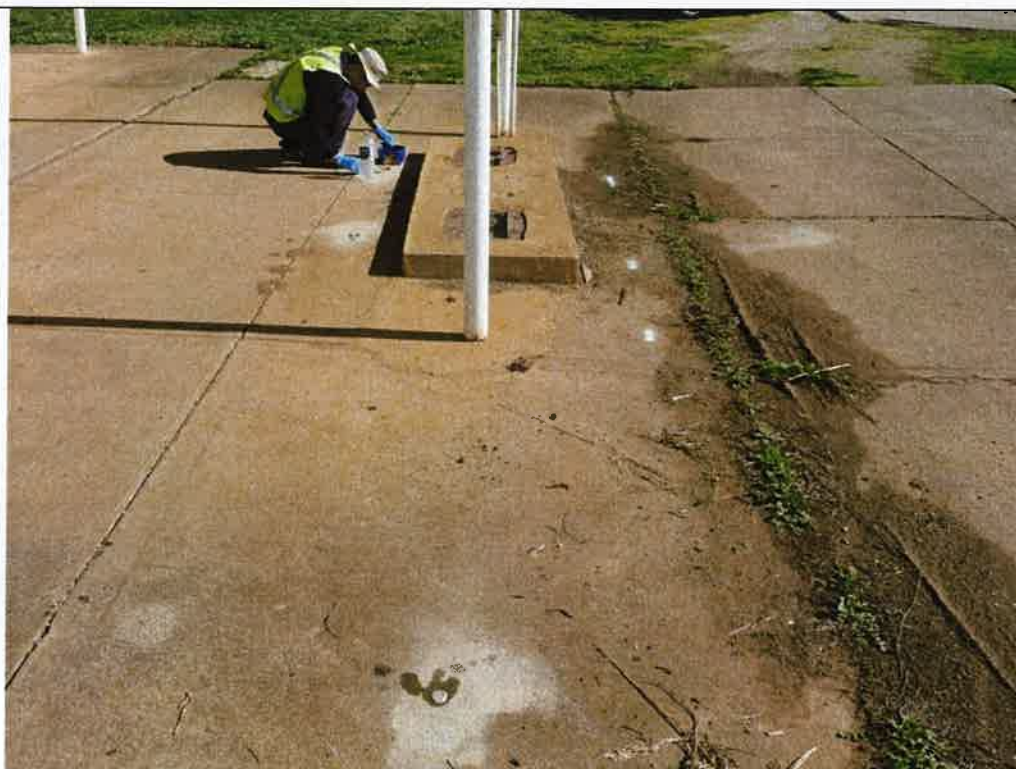
Plate 6 – Soil vapour sampling locations in the vicinity of the bowser island.

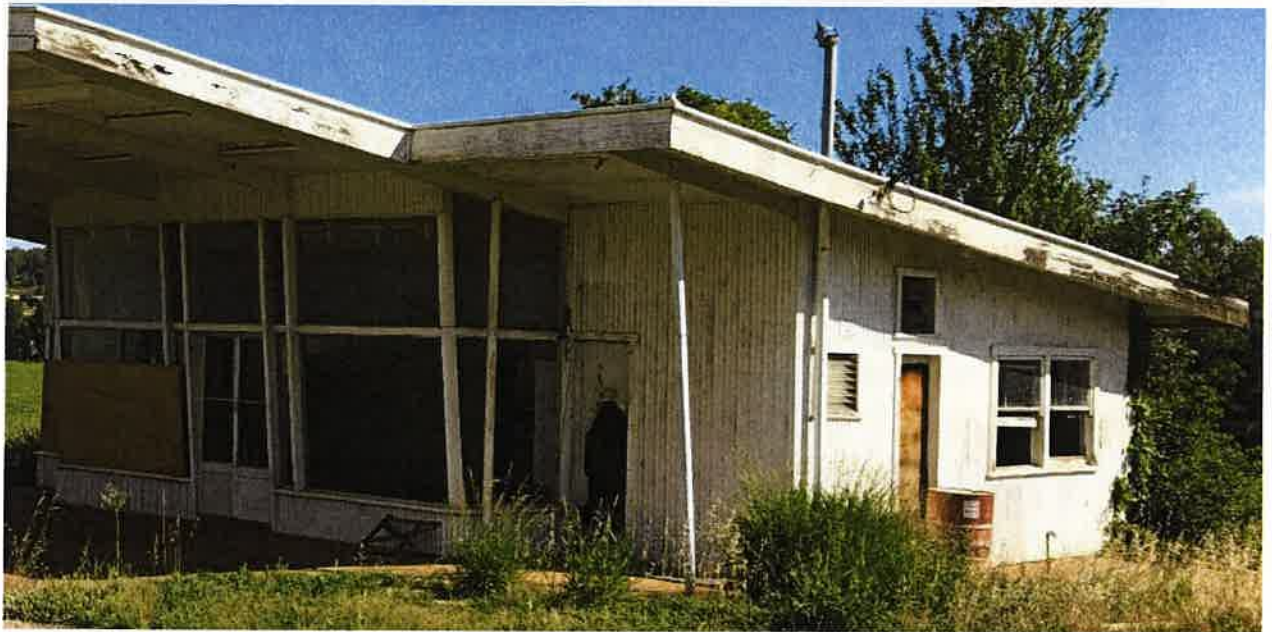
Figure 19: Detailed view of shopfront of former service station, note boarded up windows & others which have been vandalised

The existing service station building is significantly dilapidated with damaged windows, doors and external walls.

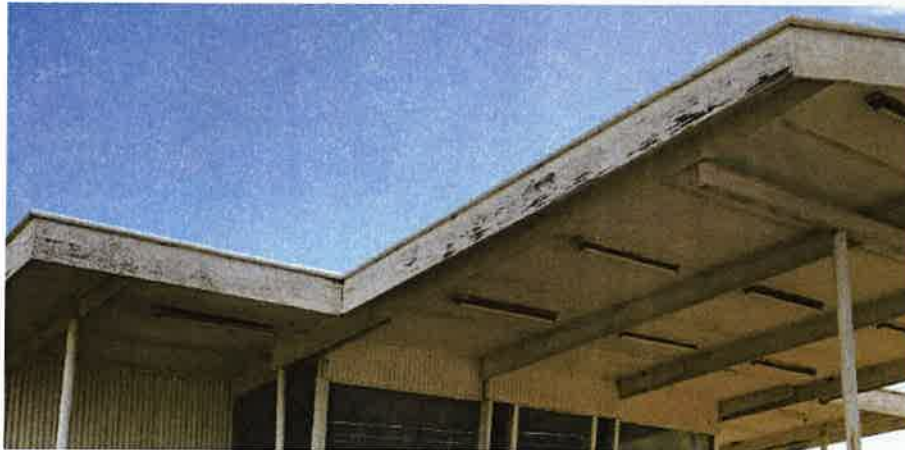
Figure 20: Detailed view of weathered and water damaged timbers

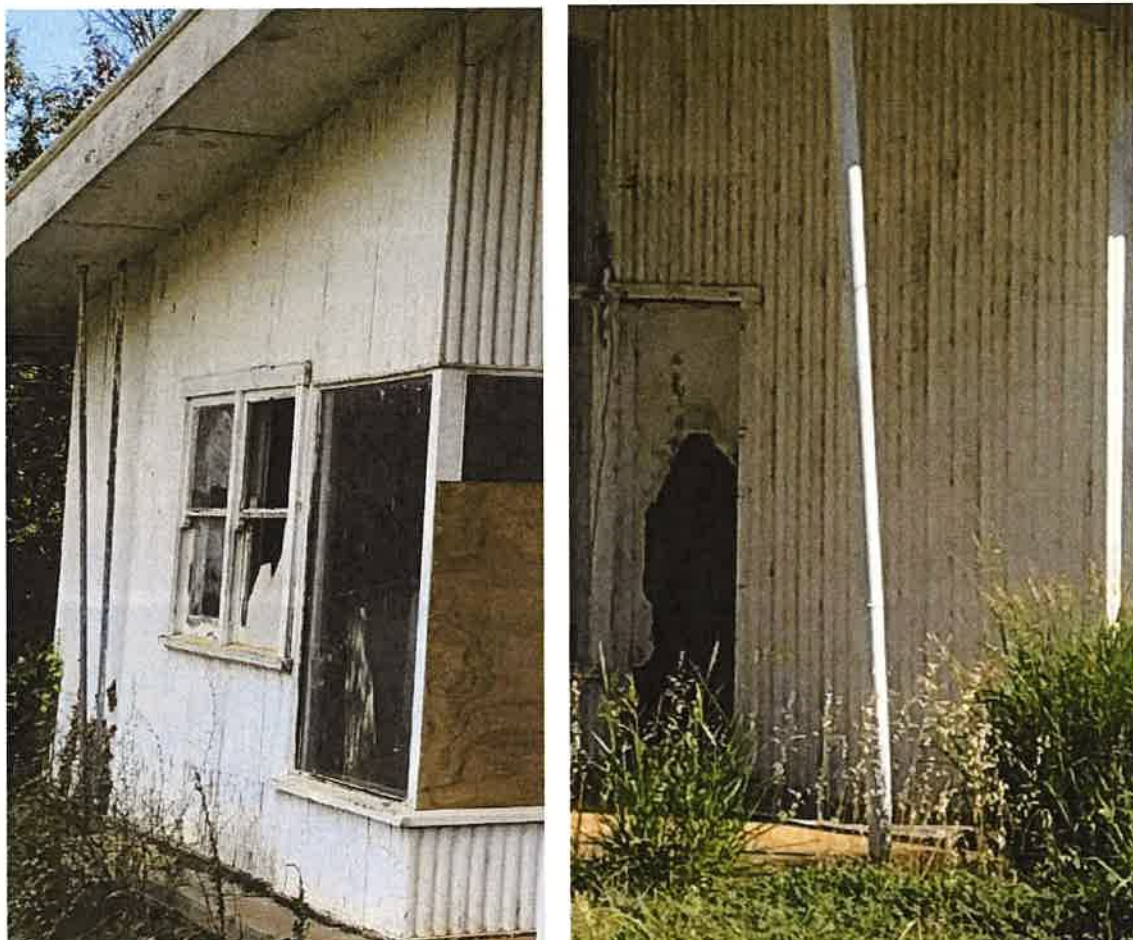
Figure 21: Detailed views of weathered and water damaged cladding

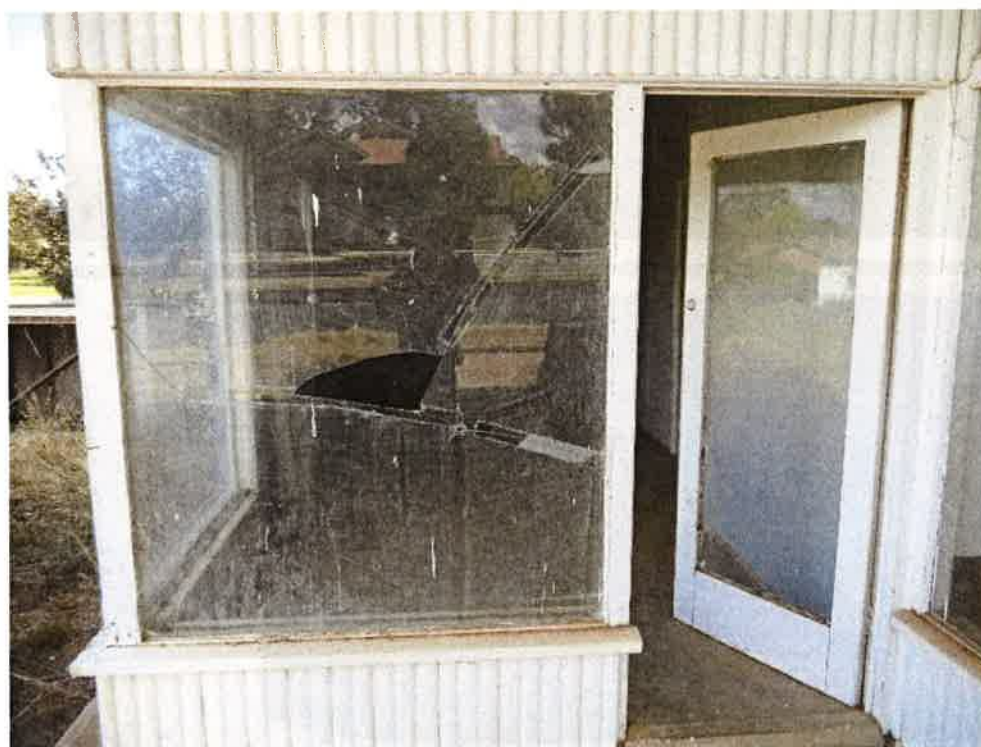
Figure 22: View of broken window on northern elevation

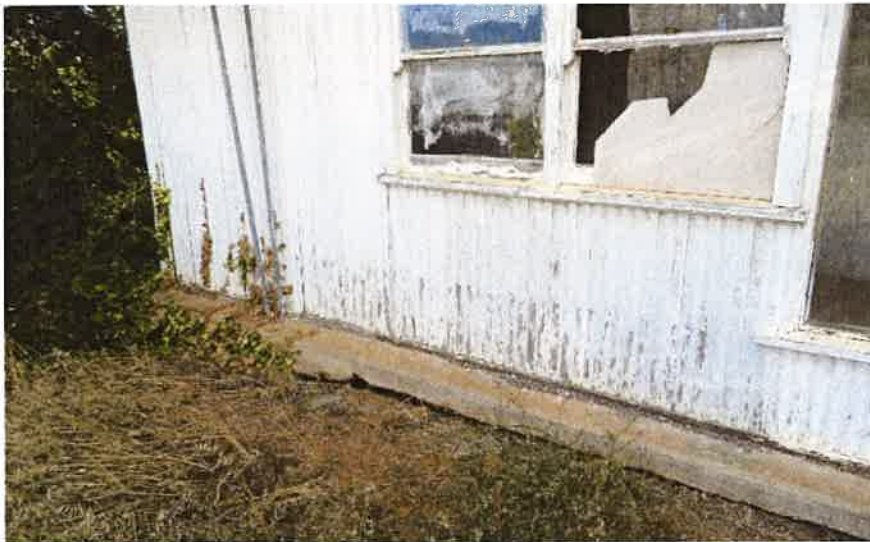
Figure 25: Detailed view of damaged cladding and timber, broken windows, gap between the ground level and concrete slab

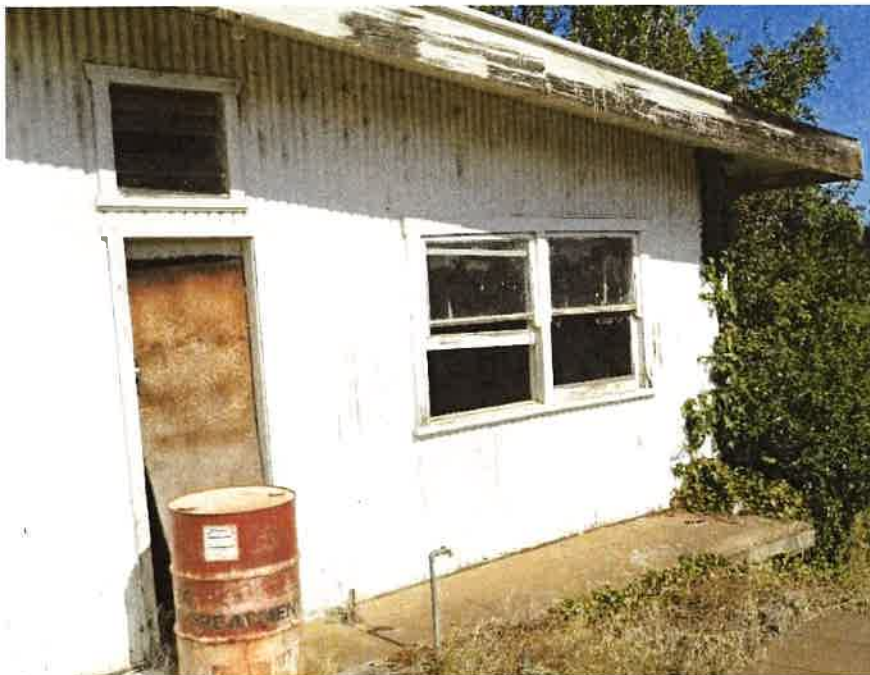
Figure 26: Detailed view of damaged cladding and timber, broken windows and door is boarded up

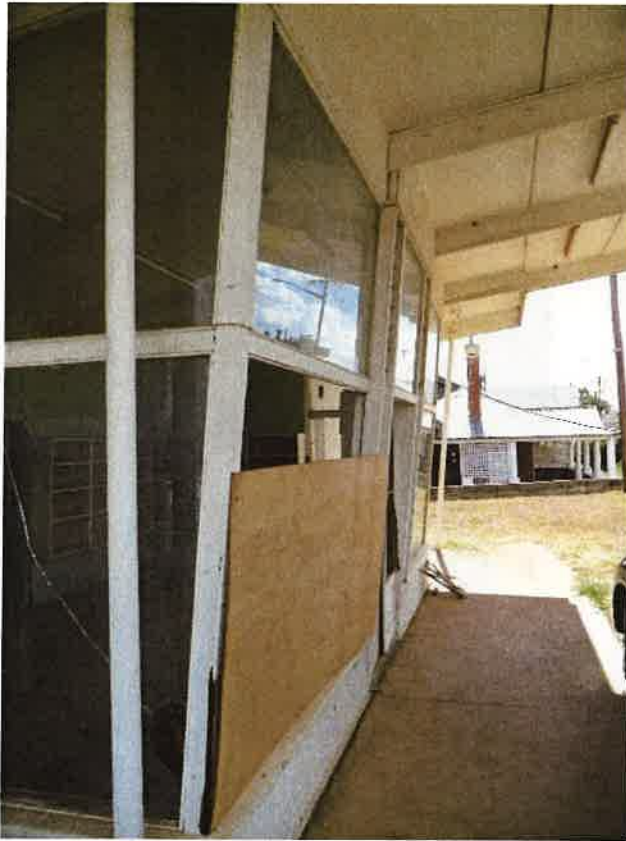
Figure 28: Detailed view of broken, boarded up windows

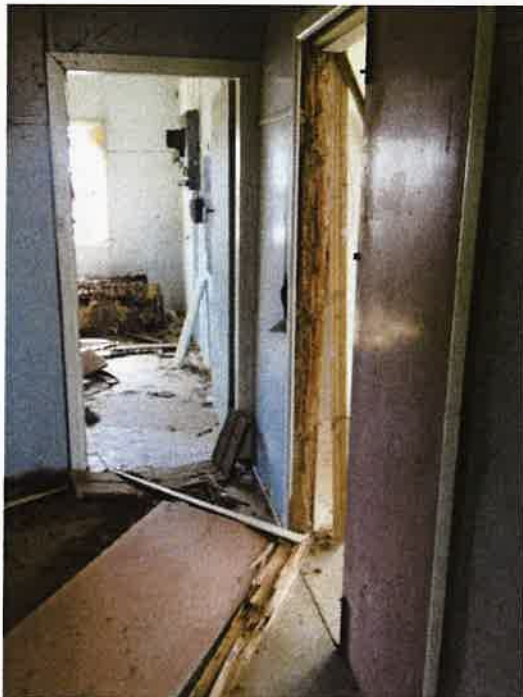
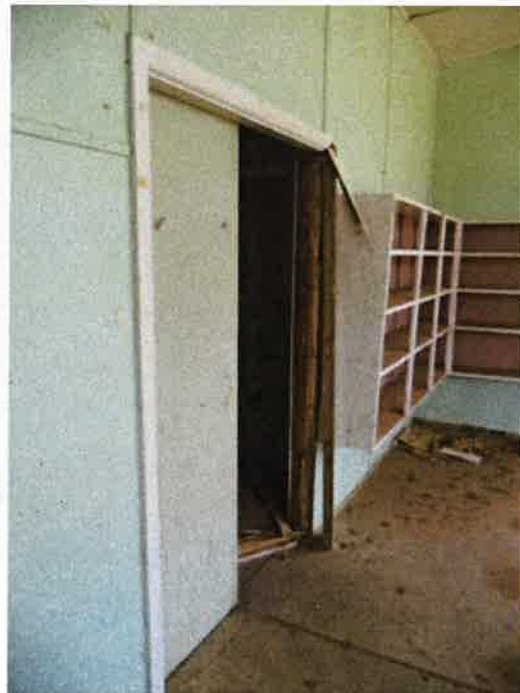
Figure 29: View of severely termite affected timber doorways

As an indication of structural damage under the sheeting, many doors do not open or close as the decayed structure has settled upon them.

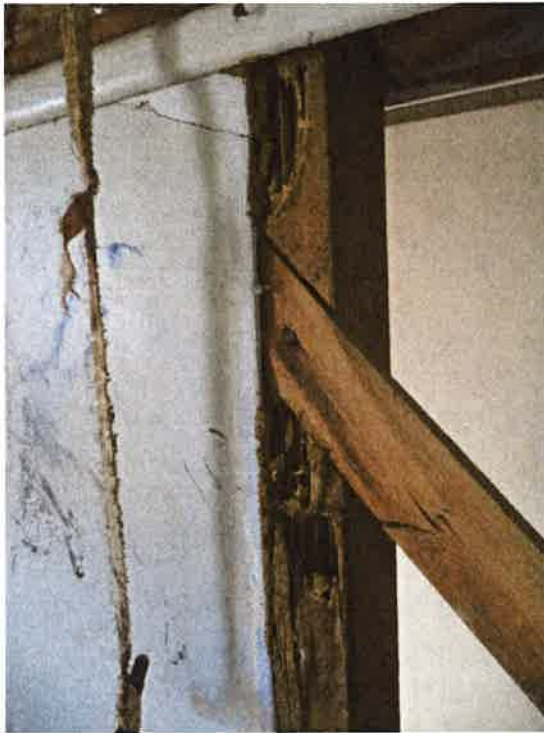
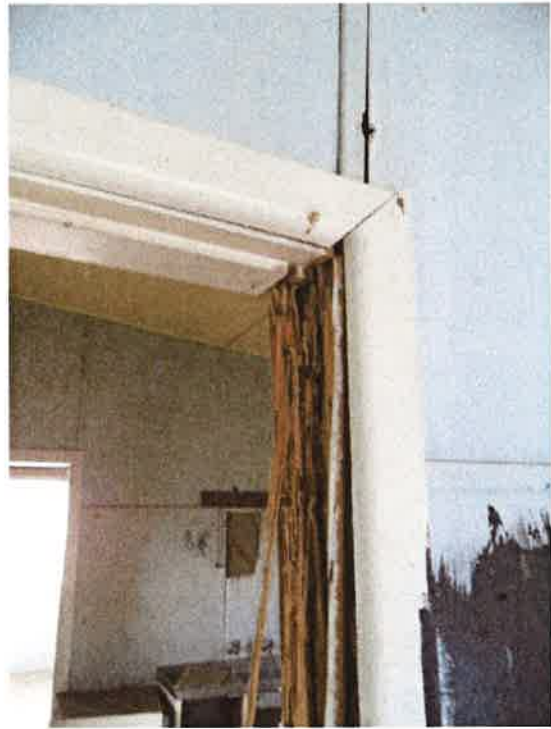
Figure 30: Detailed views of severely termite affected timbers

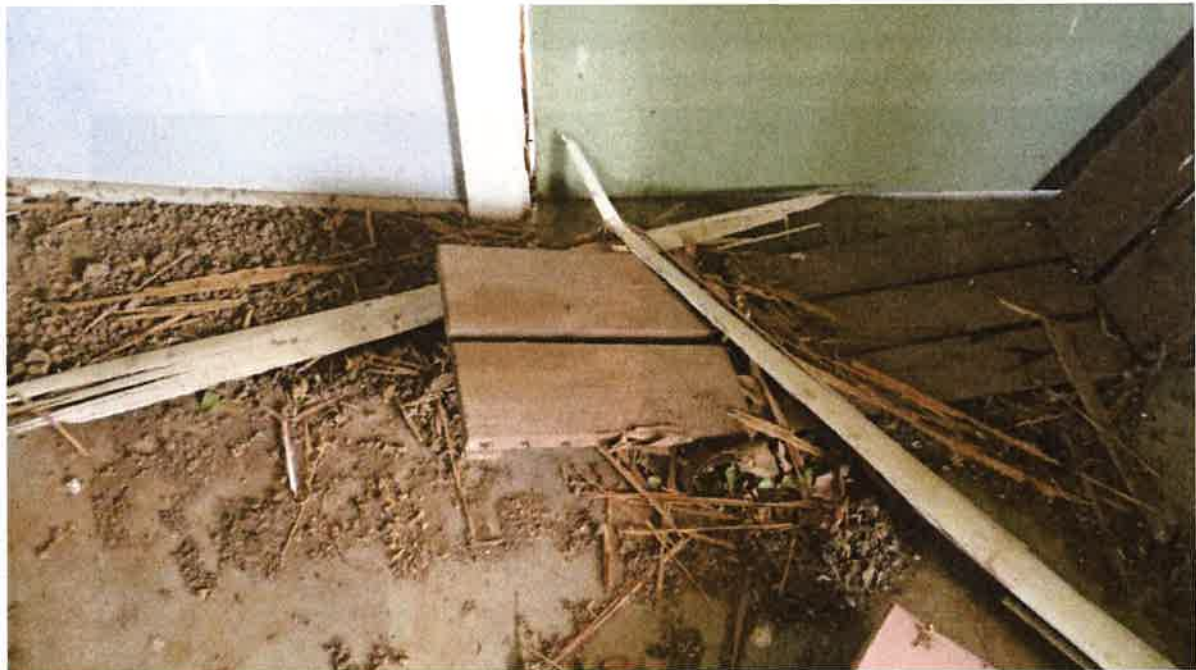
Figure 31: Detailed view fallen timbers and termite detritus

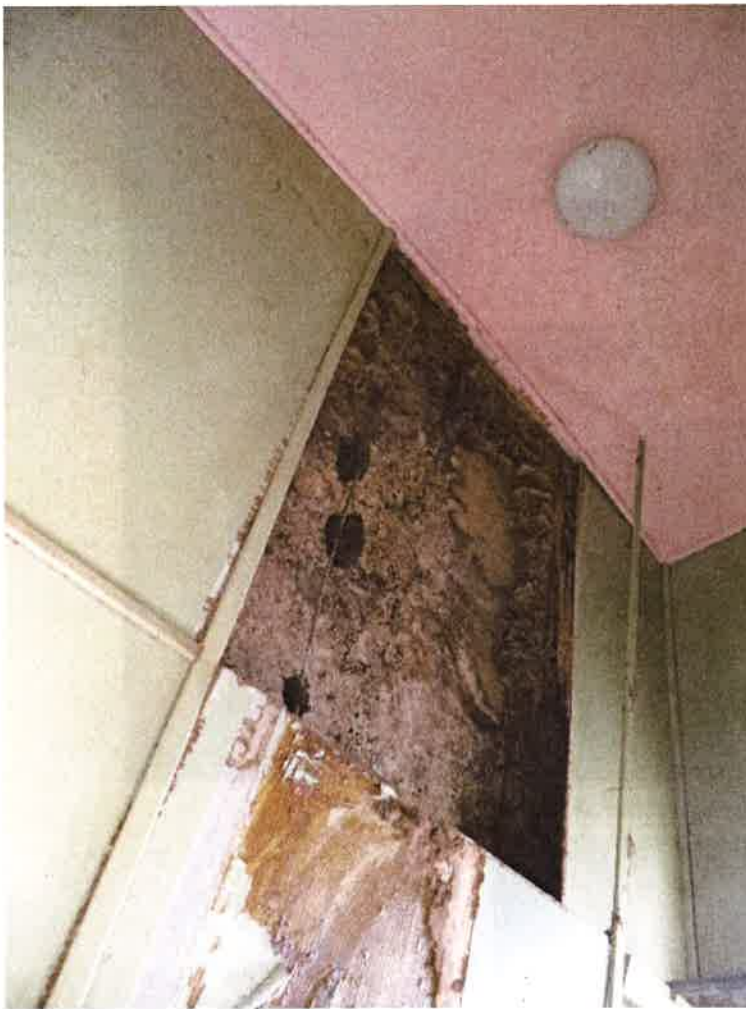
Figure 34: Fallen cladding exposing termite nests and damage to structural materials

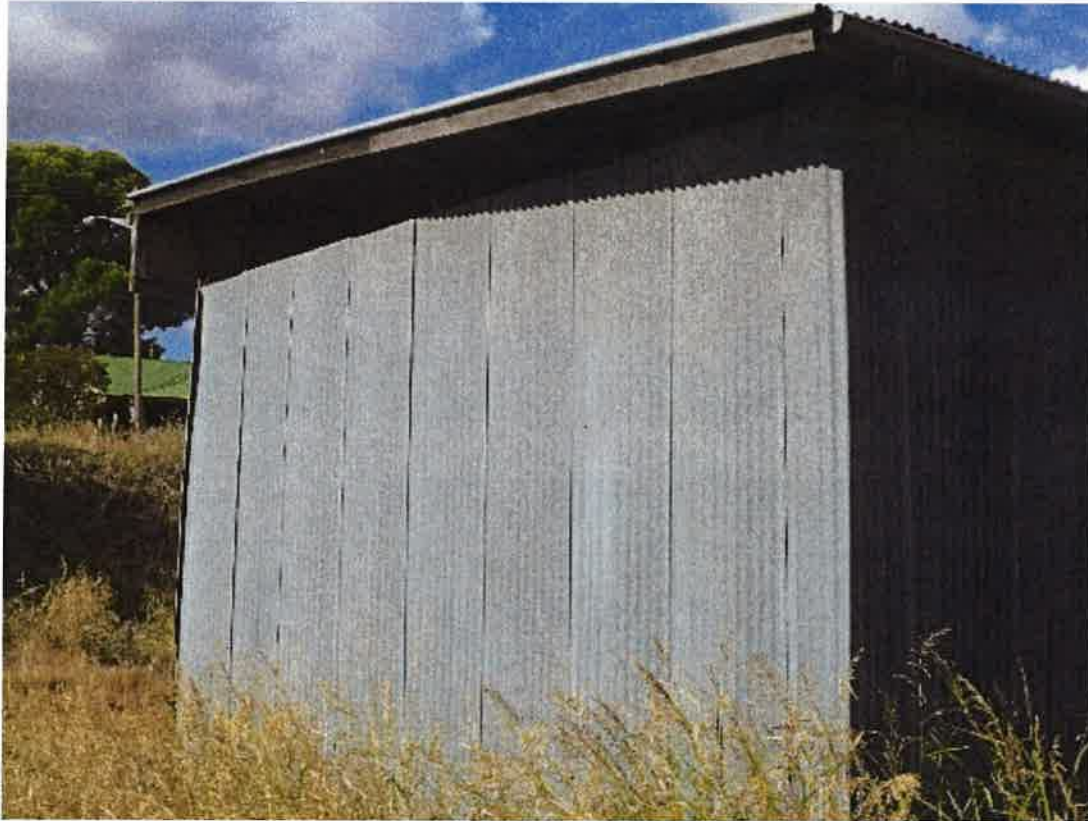
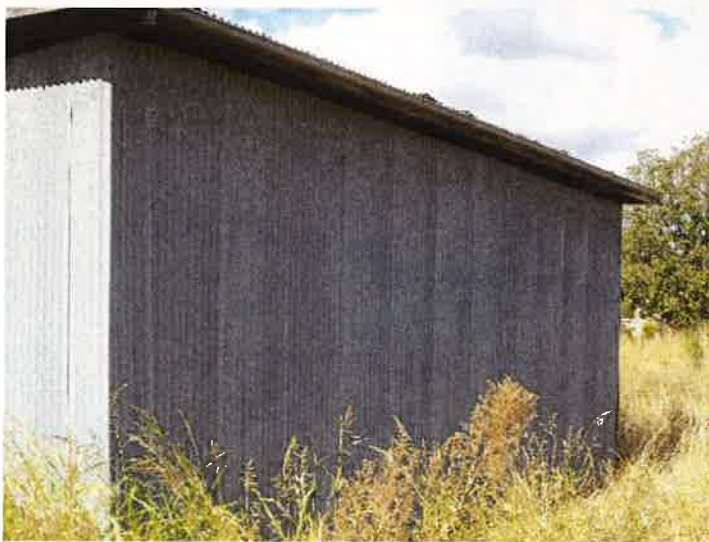
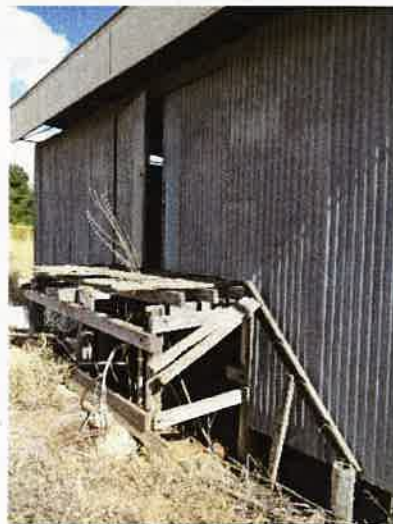
Figure 35: Views of shed exterior

The large shed on the subject lot at first glance appears to be early with a round pole foundation structure. Inside though it is recent with sawn timber frame and space frame roof construction. The iron cladding is also recent.

So while the foundations would appear earlier at first viewing, from the age of the timbers and concrete, it simply seems to be a relatively cheap, and more recent, means of keeping the building above flood level. The shed is unlikely to have any significance to the Conservation Area. In any event, it is to be retained.

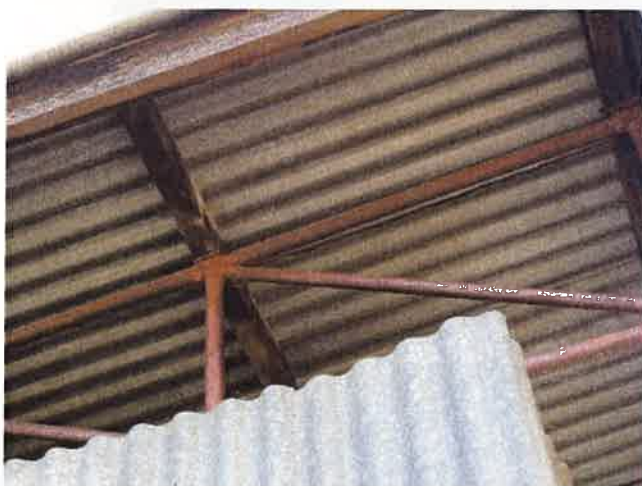
Figure 39: Space frame roof construction

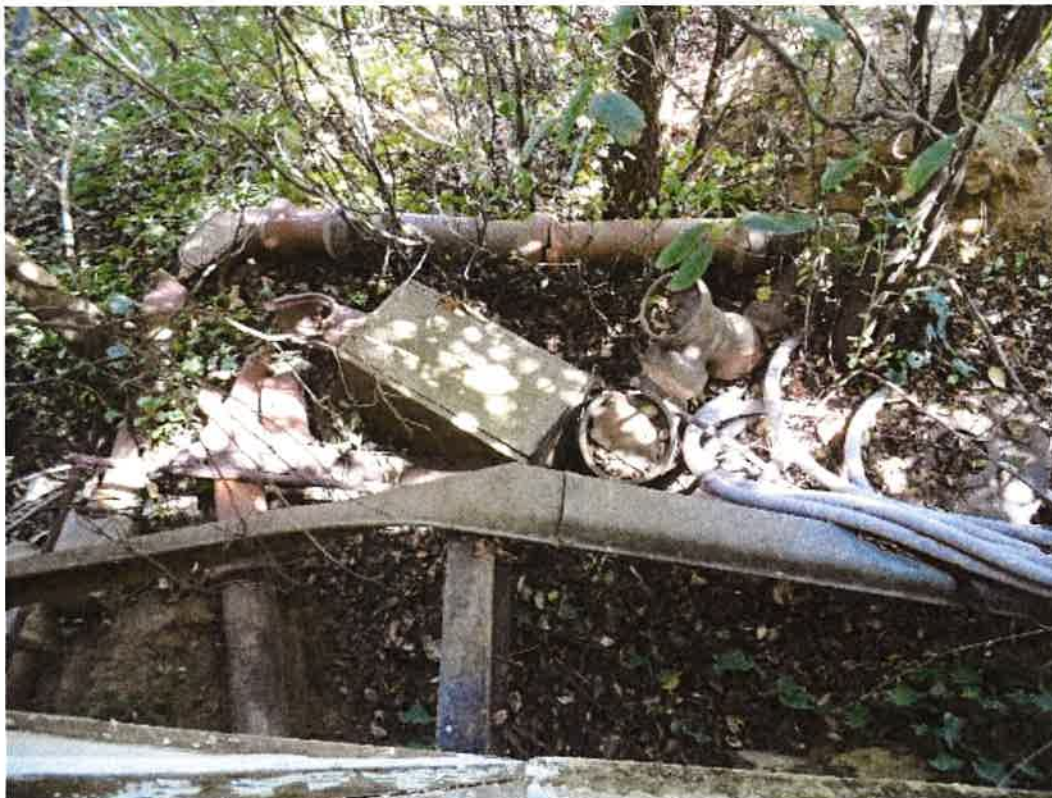
The vegetation shown below basically environmental weeds probably fostered by the shattered sewer piping at rear of the building.

Figure 41: Environmental weeds growing out of shattered sewer piping at the rear of the building

Unsurprisingly, given its former use, there is no landscape to speak of and the surrounding is in poor condition with some rubbish and many weeds, some of which are growing out of a shattered sewerage pipe.
