GEOTECHNICAL REPORT

Prepared by ASCT - Parkes office, for CABONNE COUNCIL

Molong and Manildra Showgrounds, NSW

H24-023

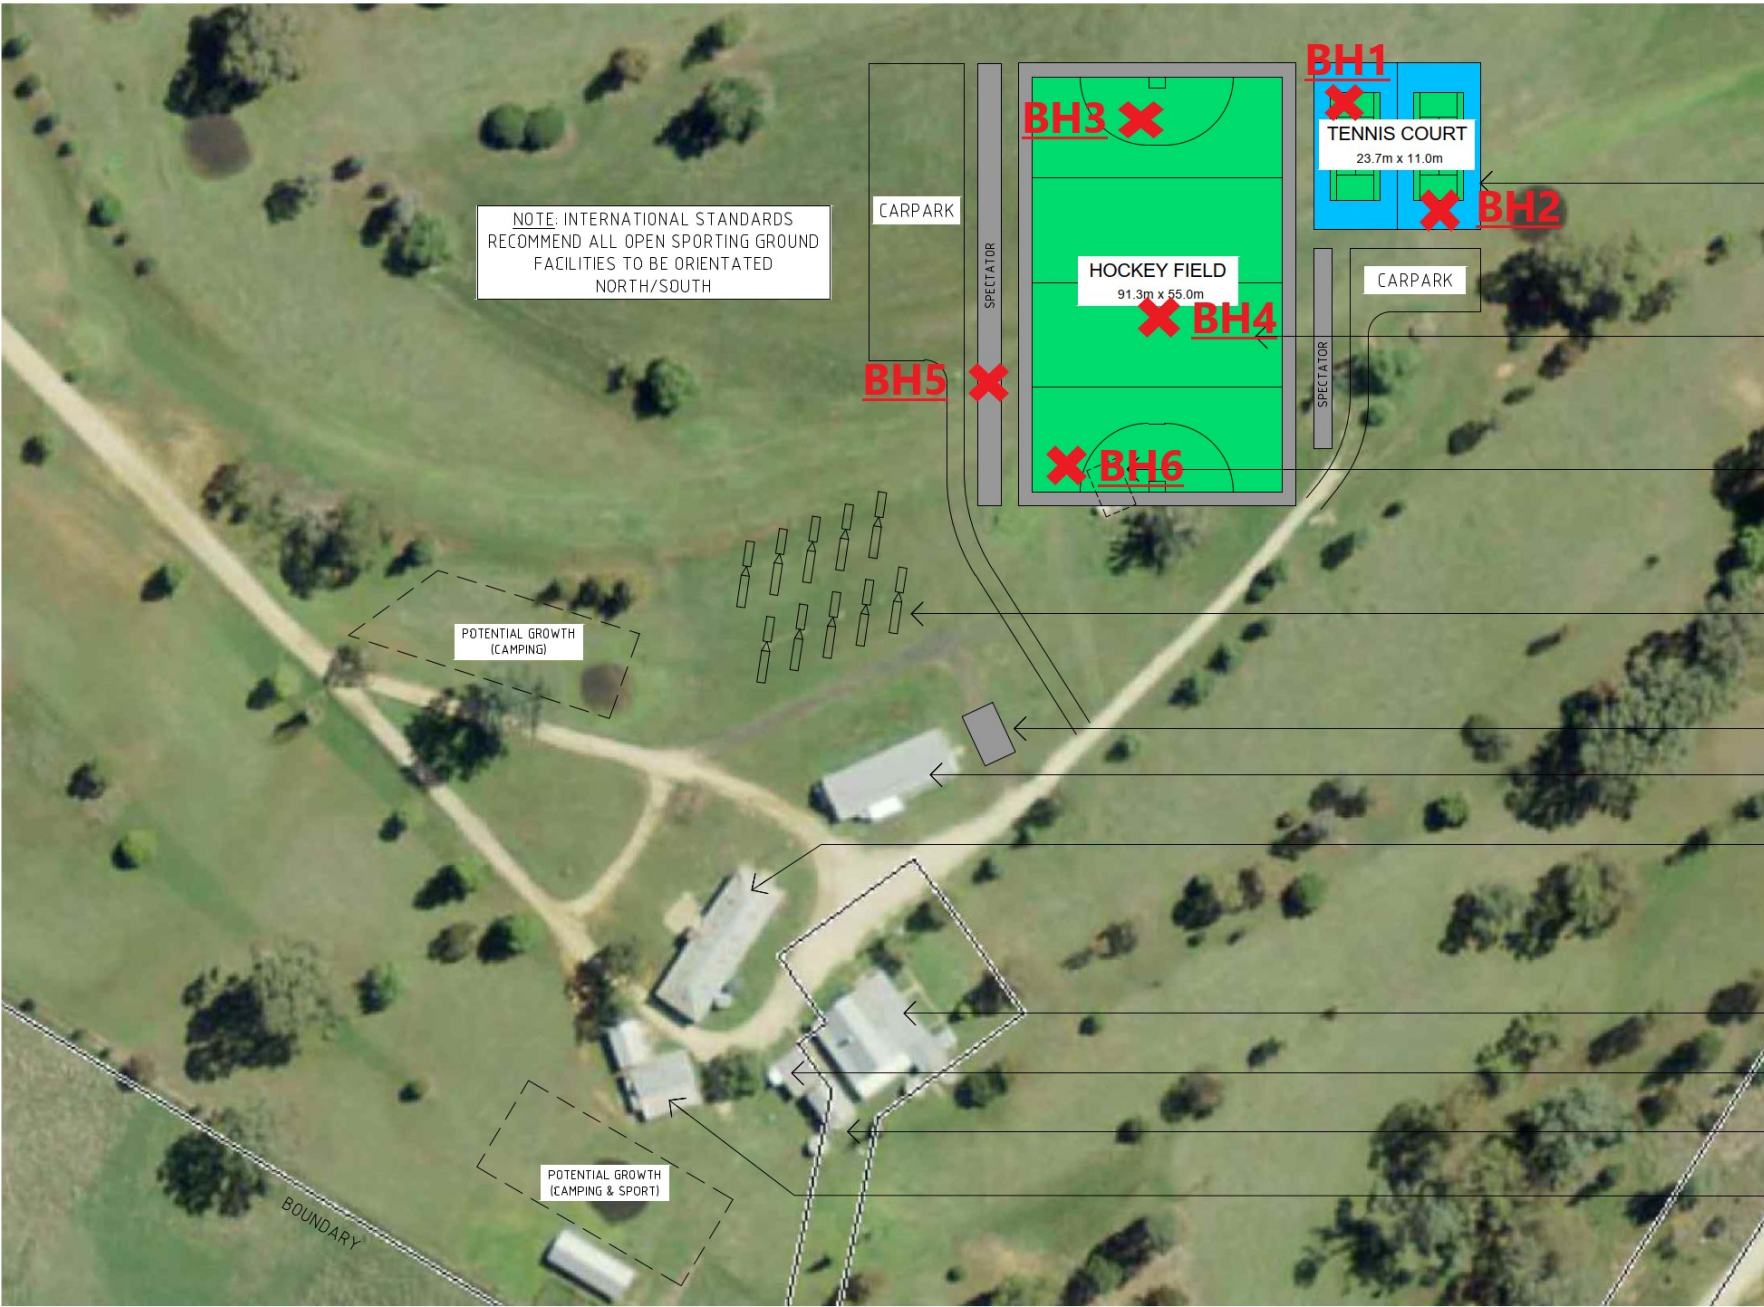
APPENDIX A – Site Plan and Borehole Logs – Molong Showground

- 2 x TENNIS COURTS
- PROPOSED HOCKEY FIELD
- EXISTING SHED/BAR
- EXISTING POWERED TOURIST PARK SITES (ACCOMM. 25 MAX.)
- EXISTING AMMENITIES BLOCK
- LUNCHEON PAVILLION
- MAIN PAVILLION
- EXISTING GOLF CLUB
- EXISTING AMMENITIES BLOCK (ORIGINAL)
- EXISTING GREEN KEEPER SHED
- EXISTING LIVESTOCK PAVILLIONS

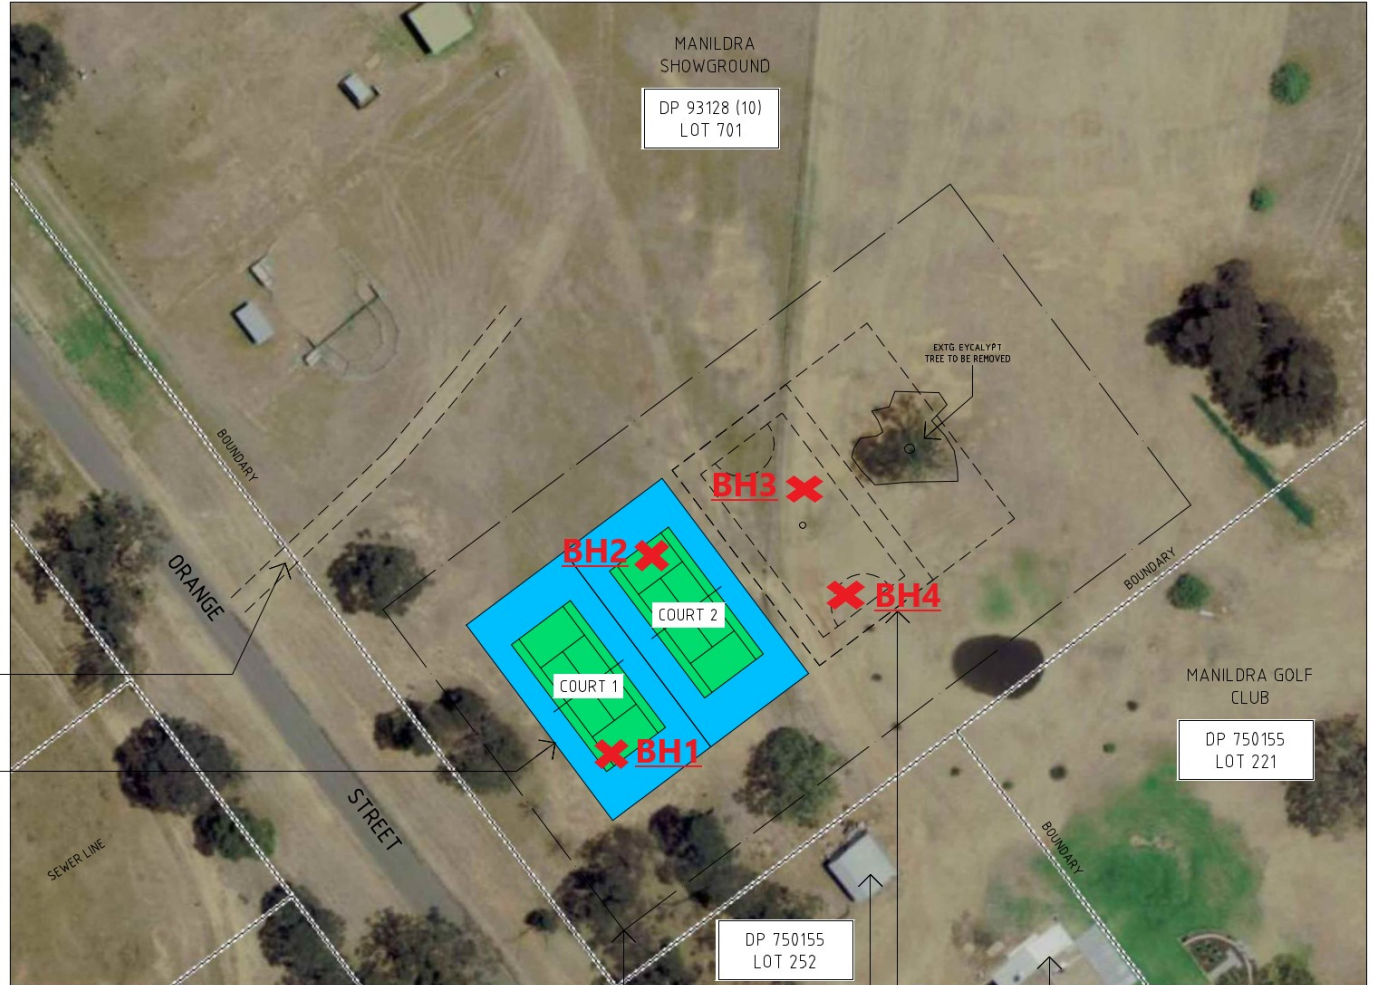
APPENDIX B – Site Plan and Borehole Logs – Manildra Showground

EXISTING ENTRY TO
SHOWGROUND

PROPOSED TENNIS COURTS
(2 x LAYKOLD SURFACE COURTS)
